Home Report

Property address	5 Orchard Park Crail Anstruther KY10 3RW
-------------------------	---

Property Owner's Completion Pack

5 Orchard Park
Crail
KY10 3RW

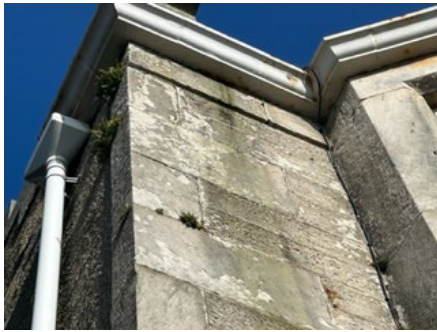
Vegetation growth to front
left hand corner of building

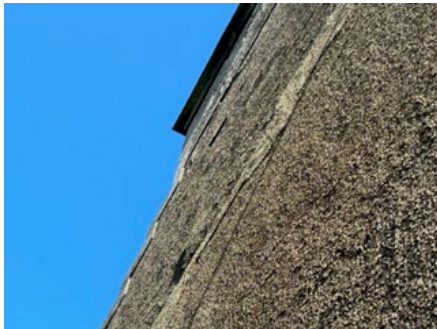
Bossed/missing harling to
left hand elevation

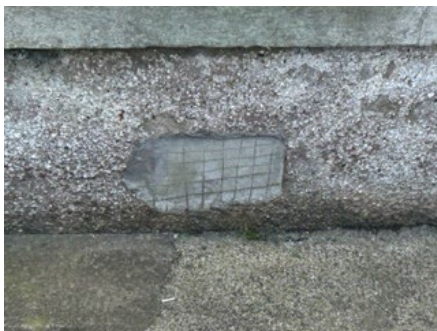
Blocked sub-floor vent to
rear elevation

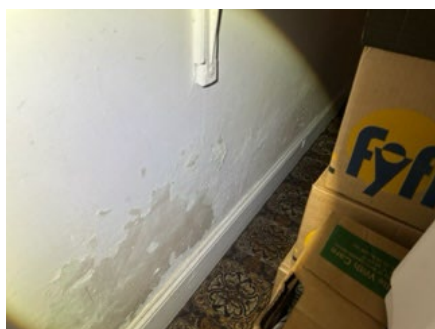
- Partial failure of the existing damp proof course.

Rising dampness within
under stair cupboard

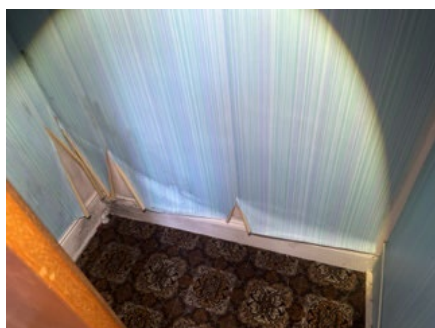
Rising dampness to room
rear right

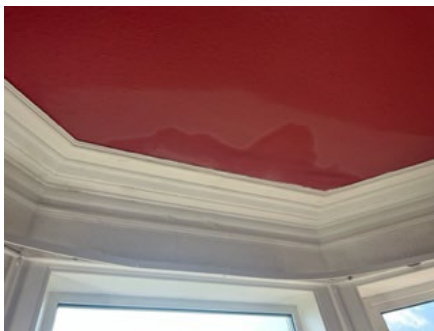
- Defective rainwater goods.
- Defective roof coverings/chimneys/skews.
- Defective stonework/pointing.
- Build-up of debris behind the internal wall finishes, permitting 'bridging' of moisture from the outer to inner wall surfaces.

Penetrating dampness to ceiling, cornice and wall fabric to ground floor room front

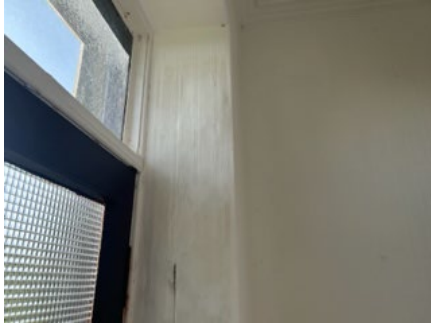
Penetrating dampness to wall fabric to ground floor vestibule

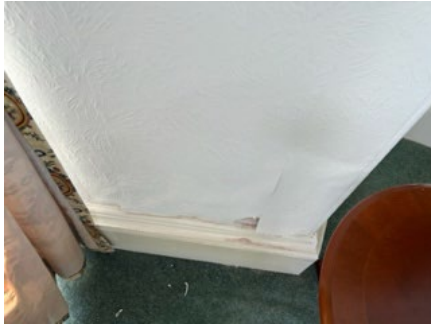
Penetrating dampness to wall fabric to 1st floor room front left

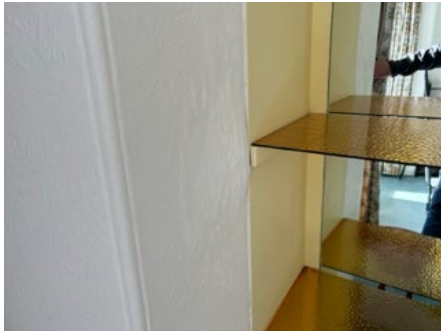
Penetrating dampness to wall fabric to 1st floor room front left

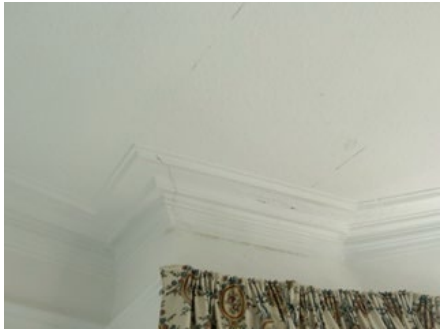
Penetrating dampness to ceiling fabric to 1st floor room front left

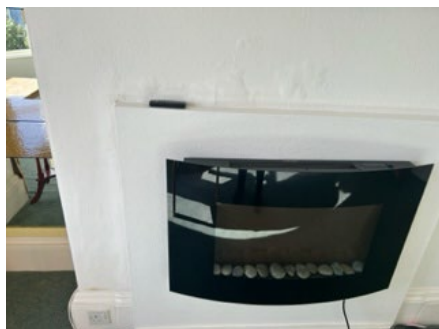
Penetrating dampness to
wall fabric to 1st floor room
front left

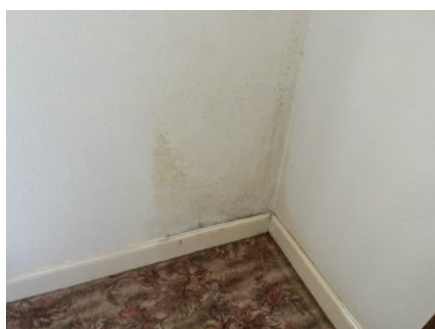
The wall surfaces to the rear right hand corner of the room were noted to be affected by mould due to excessive condensation. Condensation occurs when warm moisture-laden air, cools to 'dew-point' (the temperature at which moisture condenses) against a cold surface. Intermittent heating and insufficient ventilation provide ideal conditions for condensation. As such, proper heating and ventilation must be maintained, to reduce moisture available for evaporation into the air within the property and condensing on the cold wall surfaces.

Mould growth due to
condensation to 1st floor
room rear left

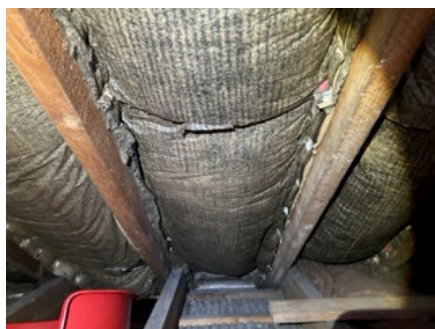
Our inspection of the roof void was restricted by the presence of quilt insulation material fitted between the rafters, flooring and stored goods.

Insulation material between
rafters to main roof void

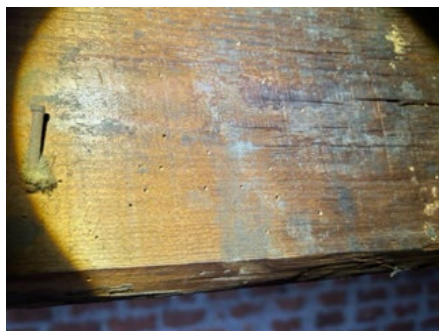
Active woodworm to roof timbers

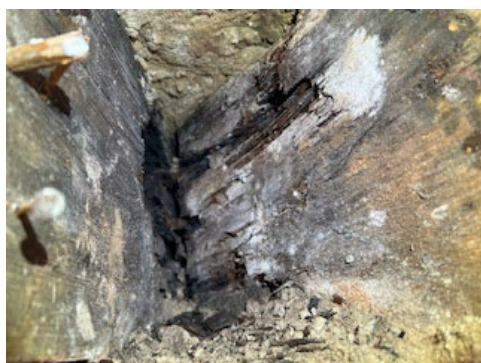
Wet rot (*Coniophora Puteana*) to the following:

Decay to bressummer beam end and joist end above bay window area to ground floor room front

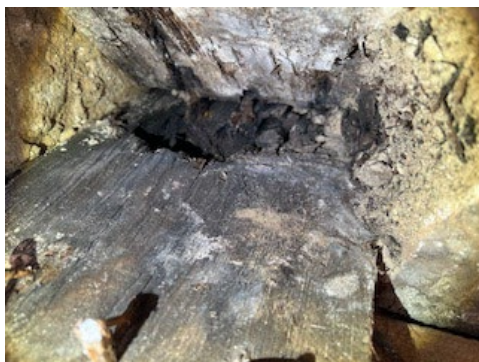
Decay to bressummer beam end

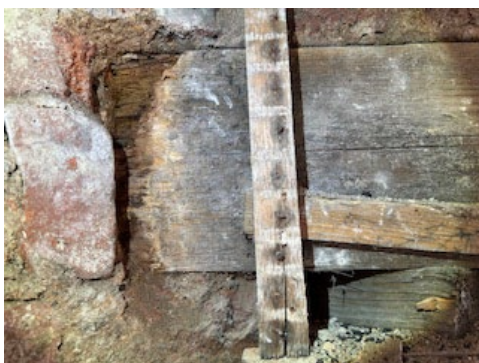
Decay to timber lintels above front door

- █ Remove/replace timber safe lintels with concrete lintels of similar dimensions.
- █ Strip wall fabric full height, fix cavity drain membrane, re-frame/board where required and plaster to finish.
- ▬ Strip ceiling fabric and cornice. Fix new plasterboard and plaster to finish. Re-run cornice to match existing.
- █ Remove bressummer beam and replace with steel beams.
- ▭ Floor joist and wallplate repairs and floorboard removal/renewal.
- Cut up door legs up to 600mm and splice new pre-treated timber sections.
