Home Report

Single Survey

| Property address | 22 Mackinlay Place Kilmarnock KA1 3DW |
| Date of inspection | 05/06/2025 |

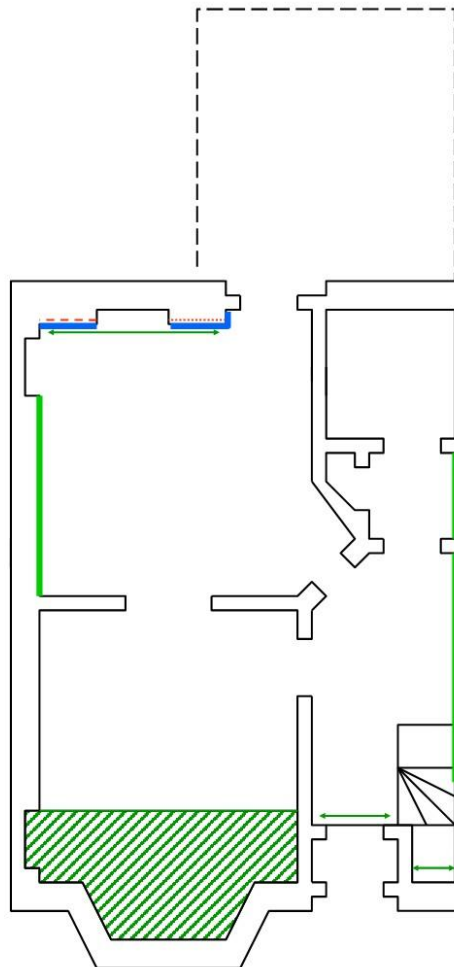
Part Ground Floor Plan

Above average damp readings were obtained to various lower wall linings at ground floor level along with upper wall linings within a rear bedroom below the chimney. Some movement was noted to the floor within the living room bay window and wood bore infestation was noted to timbers within the living room electrics cupboard, the cupboard at the bottom of the stairs and the landing cupboard.

| --- | Chemical DPC | | Renew flooring and joist sections, etc | | Strip and renew gable wall—FF Rear Bedroom |
| — | Membrane/ reline and plaster - approx 1.0m high | | Woodworm treatment to floors | | |
