Home Report

Scottish Single Survey

Property address	46 Temple Gorebridge EH23 4SQ
Customer	George Glen
Customer address	46 Temple Gorebridge EH23 4SQ
Prepared by	Shepherd Chartered Surveyors
Date of inspection	09/11/2023

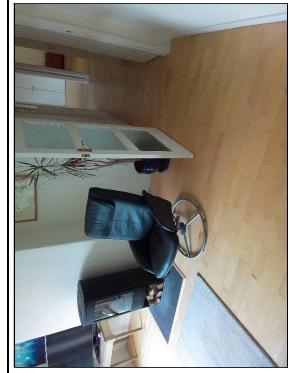
Survey Date:		Lead Surveyor		Survey Type		Floor		Analysis															
21 Nov 2023		Sean Rooney		Sampling Survey		Ground Floor		Chrysotile (1)															
Building		Room		Item		Quantity																	
46 Temple Village		All floors throughout property. G01		Vinyl Underneath existing flooring		75m ²																	
Sample No (S,SP,P,AS)		Product Type		Surface Treatment		Condition		Accessibility															
Visual (P)		Reinforced Composite (1)		Completely Sealed (0)		Good Condition (0)		Usually inaccessible or unlikely to be disturbed															
Material Risk Score																							
2																							
Recommended action		D - No Attention Required, Label																					
Surveyor comments																							
Each floor is covered by laminate flooring and it was not possible to examine the vinyl floor tiles. The floor tiles are therefore encapsulated and unlikely to be disturbed.
