HOME REPORT

3 COLONSAY PLACE
WARDNEUK
KILMARNOCK
KA3 2JU

DM HALL
CHARTERED SURVEYORS

Single Survey

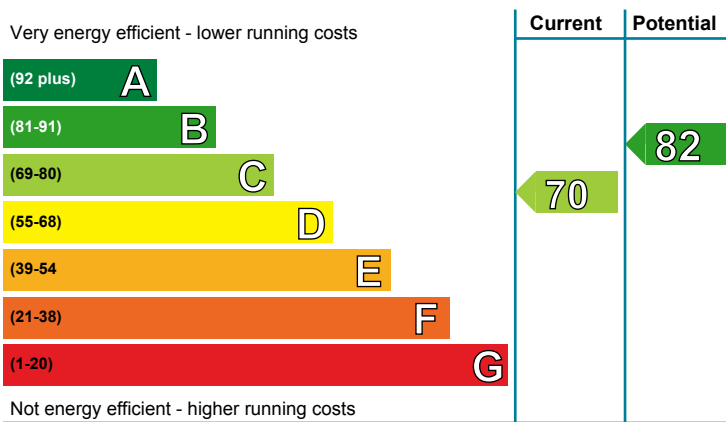
Energy Efficiency Rating

This graph shows the current efficiency of your home, taking into account both energy efficiency and fuel costs. The higher this rating, the lower your fuel bills are likely to be.

Your current rating is **band C (70)**. The average rating for EPCs in Scotland is **band D (61)**.

The potential rating shows the effect of undertaking all of the improvement measures listed within your recommendations report.

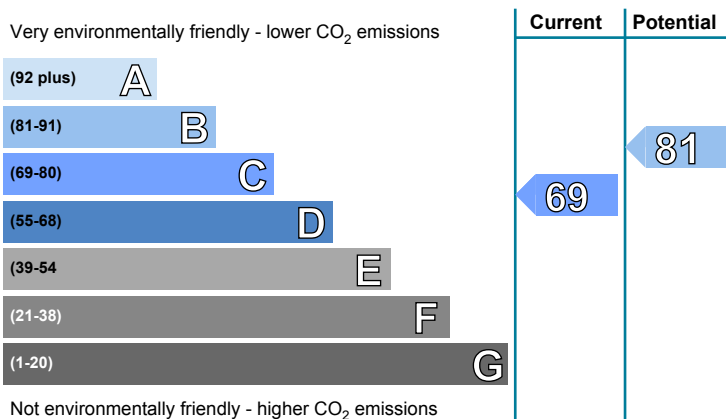
Environmental Impact (CO₂) Rating

This graph shows the effect of your home on the environment in terms of carbon dioxide (CO₂) emissions. The higher the rating, the less impact it has on the environment.

Your current rating is **band C (69)**. The average rating for EPCs in Scotland is **band D (59)**.

The potential rating shows the effect of undertaking all of the improvement measures listed within your recommendations report.
