# Home Report

96B West Main Street  
Darvel KA17 0HG

Date of Valuation: 17/09/2025

# Single Survey

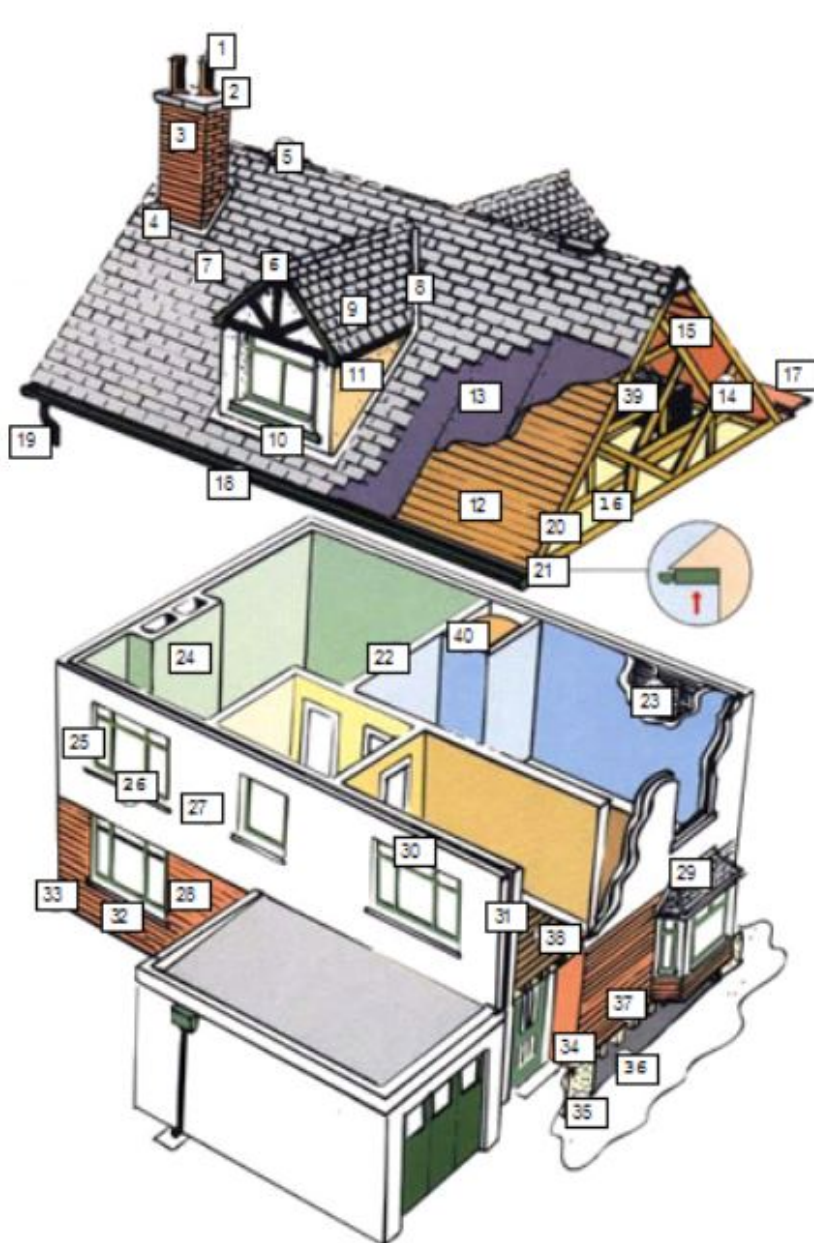
## Sectional diagram showing elements of a typical house

| 1 | Chimney pots |
| 2 | Coping stone |
| 35 | Foundations |
