espc:home report

Single Survey

Property address	Flat 9, 7 Braehead Drive, Edinburgh, EH4 6QH
-------------------------	---

Prepared by	Harvey Donaldson And Gibson
--------------------	-----------------------------

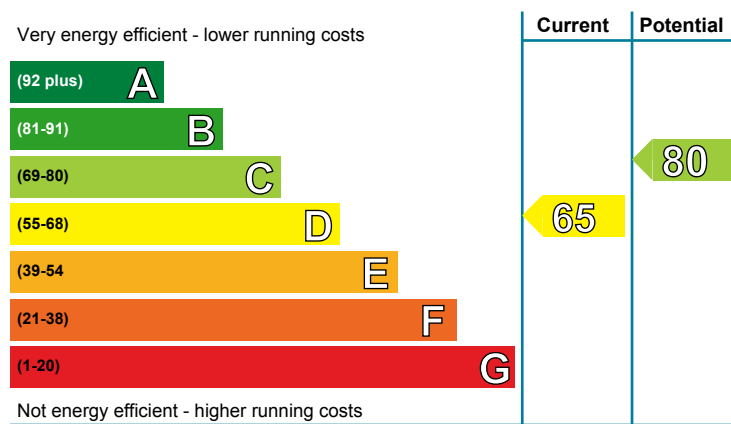
Energy Efficiency Rating

This graph shows the current efficiency of your home, taking into account both energy efficiency and fuel costs. The higher this rating, the lower your fuel bills are likely to be.

Your current rating is **band D (65)**. The average rating for EPCs in Scotland is **band D (61)**.

The potential rating shows the effect of undertaking all of the improvement measures listed within your recommendations report.

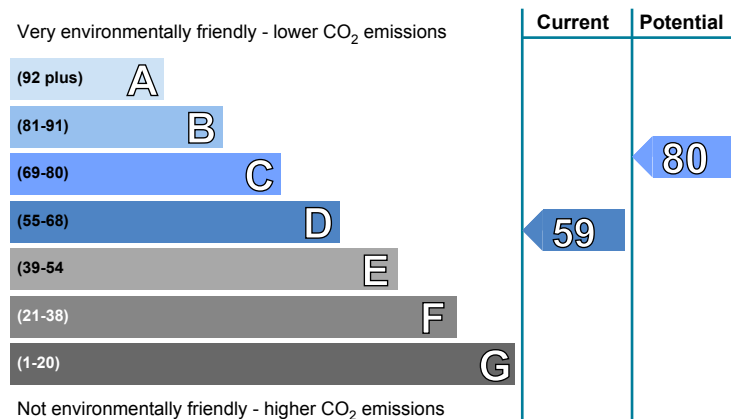
Environmental Impact (CO₂) Rating

This graph shows the effect of your home on the environment in terms of carbon dioxide (CO₂) emissions. The higher the rating, the less impact it has on the environment.
