# Home Report

# Scottish Single Survey

# Single Survey

| Property address | 9 Allen Grove<br>Comrie<br>Dunfermline<br>KY12 9XH |

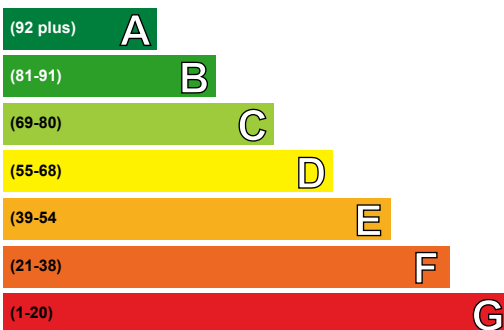
Very energy efficient - lower running costs

Not energy efficient - higher running costs
