YOUR ONESURVEY HOME REPORT

33 Caltrop Place
Stirling
FK7 7XS

SINGLE SURVEY

Single Survey

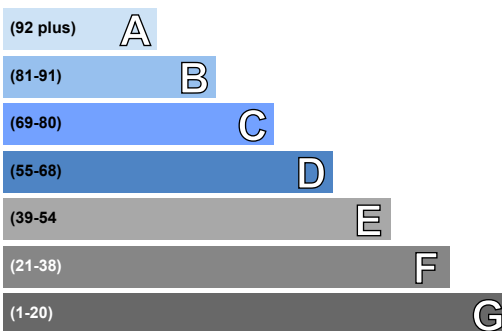
Very environmentally friendly - lower CO₂ emissions

Not environmentally friendly - higher CO₂ emissions
