HOME REPORT

12 FIR PARK
SORN
MAUCLINE
KA5 6HY

Energy Performance Certificate (EPC)

12 FIR PARK, SORN, MAUCLINE, KA5 6HY

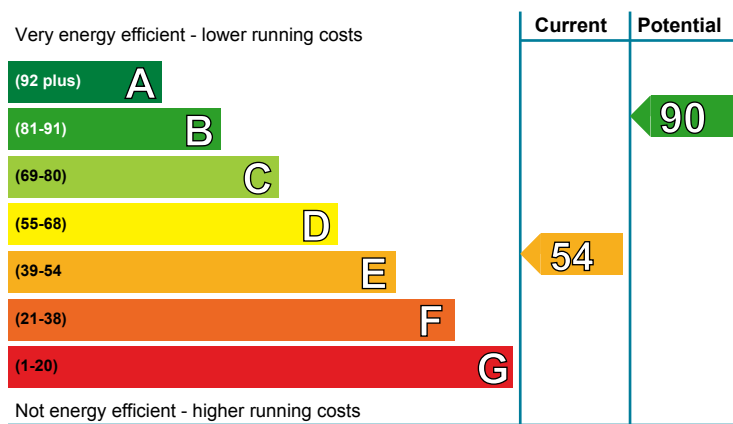
Energy Efficiency Rating

This graph shows the current efficiency of your home, taking into account both energy efficiency and fuel costs. The higher this rating, the lower your fuel bills are likely to be.

Your current rating is **band E (54)**. The average rating for EPCs in Scotland is **band D (61)**.

The potential rating shows the effect of undertaking all of the improvement measures listed within your recommendations report.

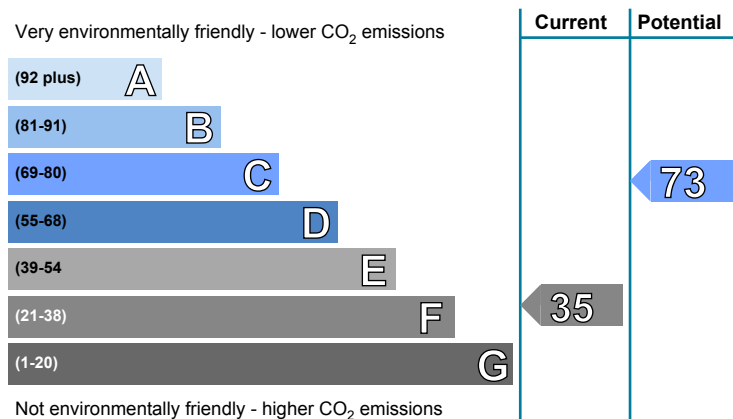
Environmental Impact (CO₂) Rating

This graph shows the effect of your home on the environment in terms of carbon dioxide (CO₂) emissions. The higher the rating, the less impact it has on the environment.

Your current rating is **band F (35)**. The average rating for EPCs in Scotland is **band D (59)**.

The potential rating shows the effect of undertaking all of the improvement measures listed within your recommendations report.
