# Home Report

# Scottish Single Survey

Property address	22 Morton Park Drive DARVEL KA17 0FB
------------------	--

Prepared by	Shepherd Chartered Surveyors
-------------	------------------------------

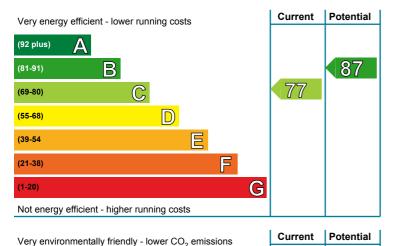
#### **Energy Efficiency Rating**

This graph shows the current efficiency of your home, taking into account both energy efficiency and fuel costs. The higher this rating, the lower your fuel bills are likely to be.
