YOUR ONESURVEY  
**HOME REPORT**

16e Elmbank Road  
Aberdeen  
AB24 3PJ

# SINGLE SURVEY

A report on the condition of the property, with categories being rated from 1 to 3.

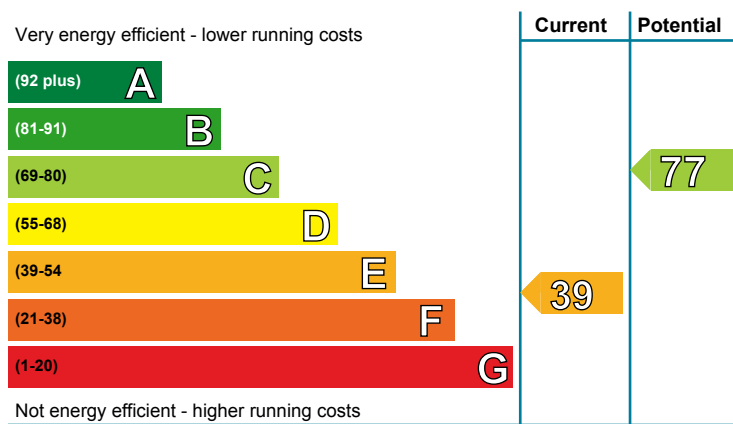
## Energy Efficiency Rating

This graph shows the current efficiency of your home, taking into account both energy efficiency and fuel costs. The higher this rating, the lower your fuel bills are likely to be.

Your current rating is **band E (39)**. The average rating for EPCs in Scotland is **band D (61)**.

The potential rating shows the effect of undertaking all of the improvement measures listed within your recommendations report.

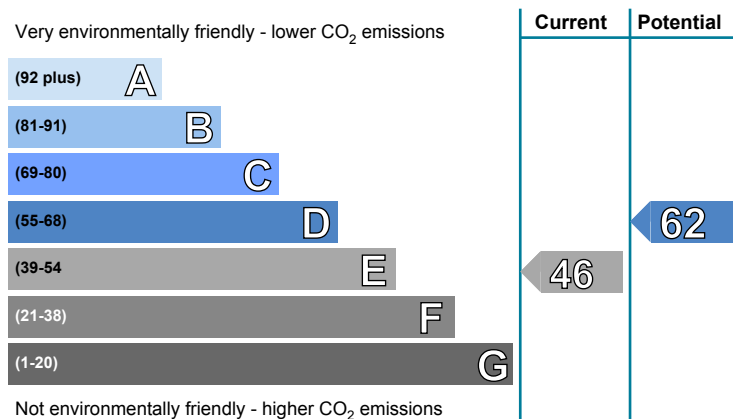
## Environmental Impact (CO<sub>2</sub>) Rating

This graph shows the effect of your home on the environment in terms of carbon dioxide (CO<sub>2</sub>) emissions. The higher the rating, the less impact it has on the environment.
