# Home Report

Rahane Bracklinn Road Callander FK17 8EQ

# single survey

Property address	Rahane Bracklinn Road Callander FK17 8EQ
Customer	Mr James Lind
Prepared by	Graham + Sibbald LLP

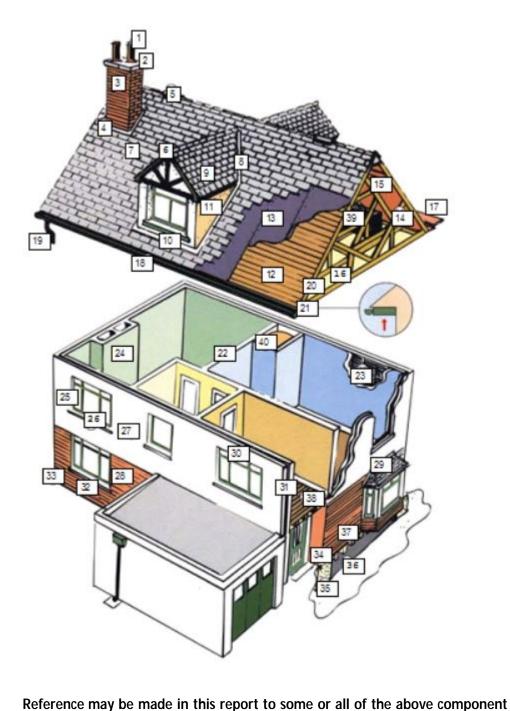
### Sectional Diagram showing elements of a typical house

Coping stone 2 3 Chimney head Flashing 4 Ridge ventilation 5 Ridge board 6 7 Slates/tiles 8 Valley guttering 9 Dormer projection Dormer flashing 10 Dormer cheeks 11 12 Sarking Roof felt 13 Trusses 14 15 Collar 16 Insulation 17 Parapet gutter Eaves guttering 18 Rainwater downpipe 19 20 Verge boards / skews 21 Soffit boards 22 Partition wall Lath / plaster 23 24 Chimney breast 25 Window pointing Window sills 26 Rendering 27 Brickwork / pointing 28 Bay window 29 30 Lintels 31 Cavity walls / wall ties Subfloor ventilator 32 33 Damp proof course 34 Base course 35 Foundations Solum 36 37 Floor joists Floorboards 38 Water tank 39 40 Hot water tank parts of the property. This diagram may assist you in locating and understanding
