# Home Report

# Scottish Single Survey

<b>Property address</b>	24 London Road Kilmarnock KA3 7AQ
<b>Customer</b>	Mr & Mrs G Deane
<b>Customer address</b>	24 London Road Kilmarnock KA3 7AQ
<b>Prepared by</b>	Shepherd Chartered Surveyors
<b>Date of inspection</b>	25/03/2026

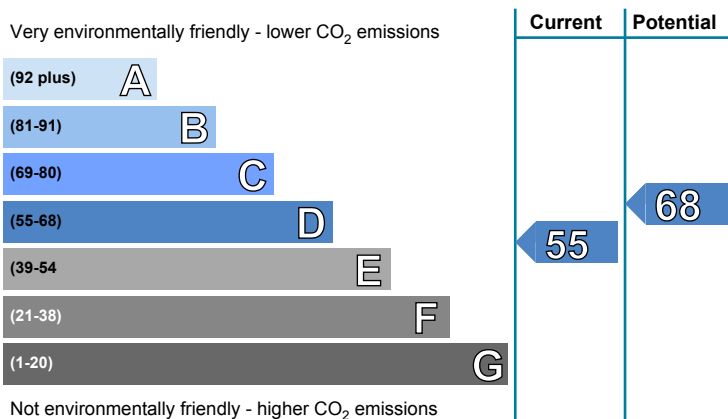
## Environmental Impact (CO<sub>2</sub>) Rating

This graph shows the effect of your home on the environment in terms of carbon dioxide (CO<sub>2</sub>) emissions. The higher the rating, the less impact it has on the environment.
