Home Report

Single Survey

Property address	2 Hadden Farm Cottages Kelso TD5 8HU
Customer	Ms Zena McFadzean & Mr Iain Fullarton
Customer address	2 Hadden Farm Cottages Kelso TD5 8HU
Prepared by	Shepherd Chartered Surveyors
Date of inspection	01/05/2025

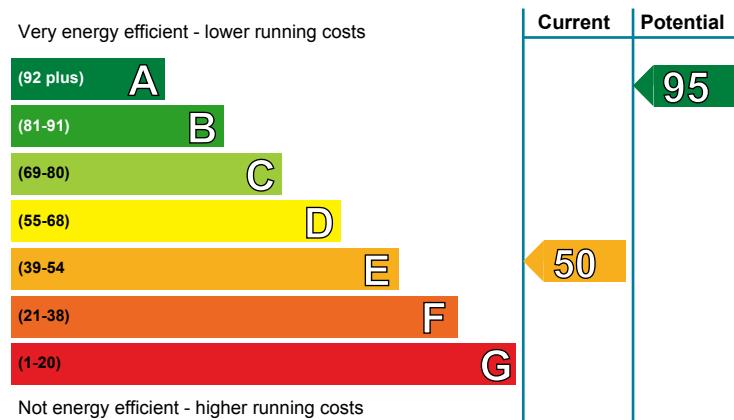
Energy Efficiency Rating

This graph shows the current efficiency of your home, taking into account both energy efficiency and fuel costs. The higher this rating, the lower your fuel bills are likely to be.

Your current rating is **band E (50)**. The average rating for EPCs in Scotland is **band D (61)**.

The potential rating shows the effect of undertaking all of the improvement measures listed within your recommendations report.

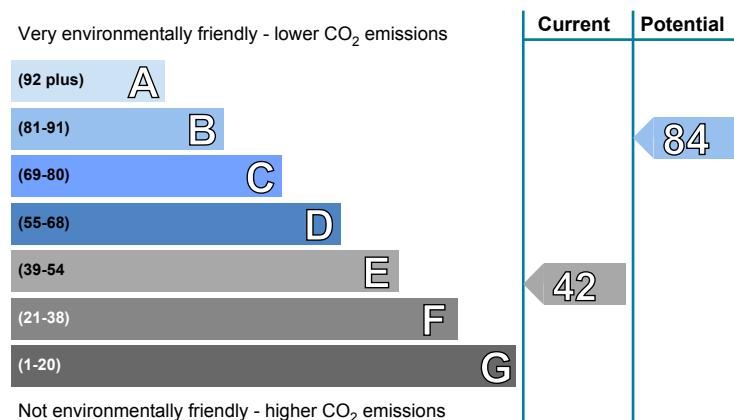
Environmental Impact (CO₂) Rating

This graph shows the effect of your home on the environment in terms of carbon dioxide (CO₂) emissions. The higher the rating, the less impact it has on the environment.
