Home Report

16 Clearmount Avenue Newmilns KA16 9ER

Single Survey

Survey report on:

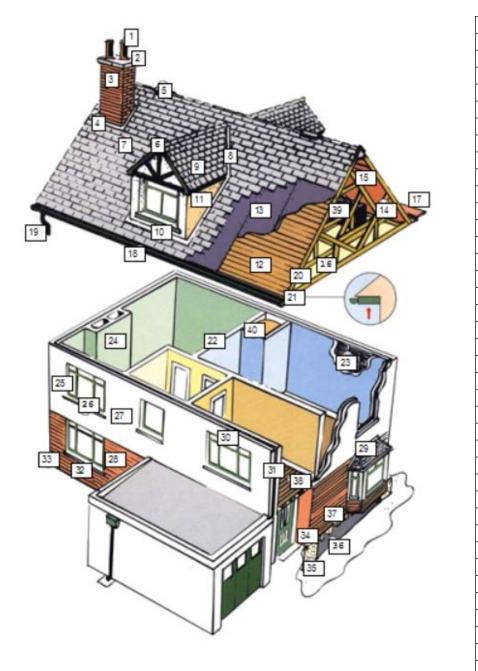
Sectional diagram showing elements of a typical house

| | _ |
|---|---|
| 1 | Chimney pots |
| 35 | Foundations |
