Home Report

30 London Road Kilmarnock KA3 7AQ

single survey

Prepared by	Graham + Sibbald LLP
-------------	----------------------

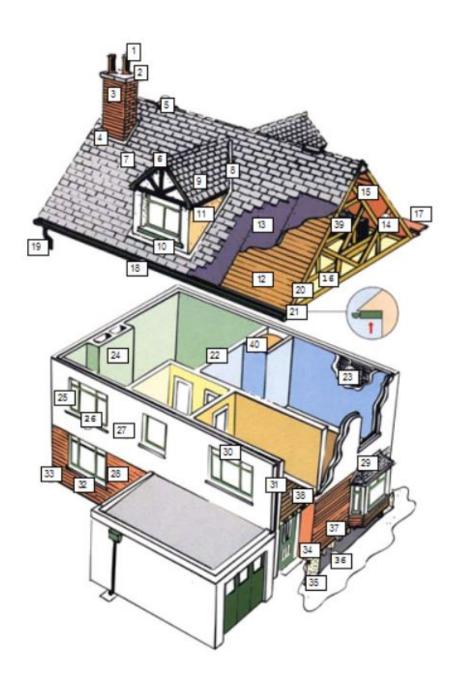
Sectional Diagram showing elements of a typical house

- Chimney pots
- 2 Coping stone
- 3 Chimney head
- Flashing 4
- Ridge ventilation
- Ridge board
- Slates/tiles
- Valley guttering 8
- Dormer projection 9
- 10 Dormer flashing
- 11 Dormer cheeks
- 12 Sarking
- Roof felt 13
- Trusses 14
- 15 Collar
- Insulation 16
- Parapet gutter 17
- Eaves guttering 18
- 19 Rainwater downpipe
- 20 Verge boards / skews
- Soffit boards 21
- Partition wall 22
- Lath / plaster 23
- 24 Chimney breast
- 25 Window pointing
- Window sills 26
- Rendering 27
- Brickwork / pointing 28
- window Bay 29
 - projection
- 30 Lintels
- Cavity walls / wall ties 31
- Subfloor ventilator 32
- Damp proof course 33
- Base course 34
- 35 **Foundations**
- Solum 36
- 37 Floor joists
- 38 Floorboards
- 39 Water tank
- 40 Hot water tank

Reference may be made in this report to some or all of the above component parts of the property. This diagram may assist you in locating and understanding these items.
