Home Report

Scottish Single Survey

Property address	40 Wilderhaugh Galashiels TD1 1PW
Customer	John Forth
Customer address	40 Wilderhaugh Galashiels TD1 1PW
Prepared by	Shepherd Chartered Surveyors
Date of inspection	21/02/2024

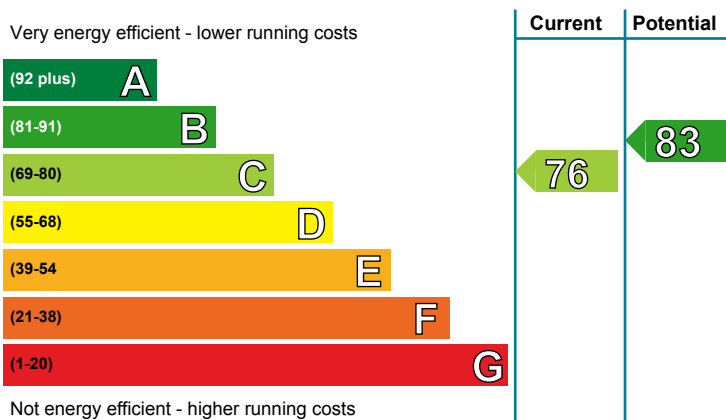
Energy Efficiency Rating

This graph shows the current efficiency of your home, taking into account both energy efficiency and fuel costs. The higher this rating, the lower your fuel bills are likely to be.

Your current rating is **band C (76)**. The average rating for EPCs in Scotland is **band D (61)**.

The potential rating shows the effect of undertaking all of the improvement measures listed within your recommendations report.

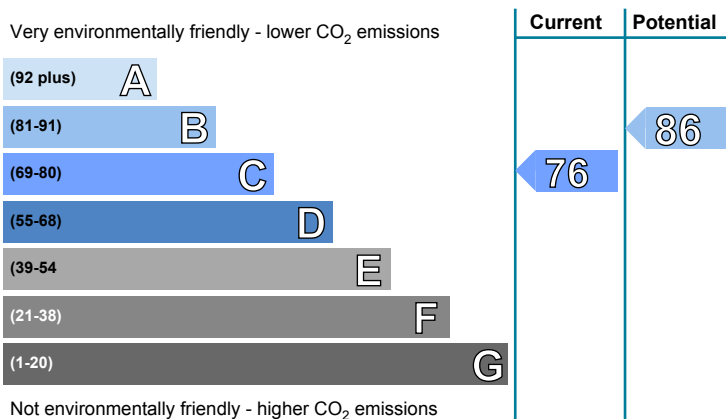
Environmental Impact (CO₂) Rating

This graph shows the effect of your home on the environment in terms of carbon dioxide (CO₂) emissions. The higher the rating, the less impact it has on the environment.
