# Home Report

18 Linfern Avenue West Kilmarnock KA1 3LH

### Single Survey

Description         A semi-detached single storey and attic chalet villa.
---

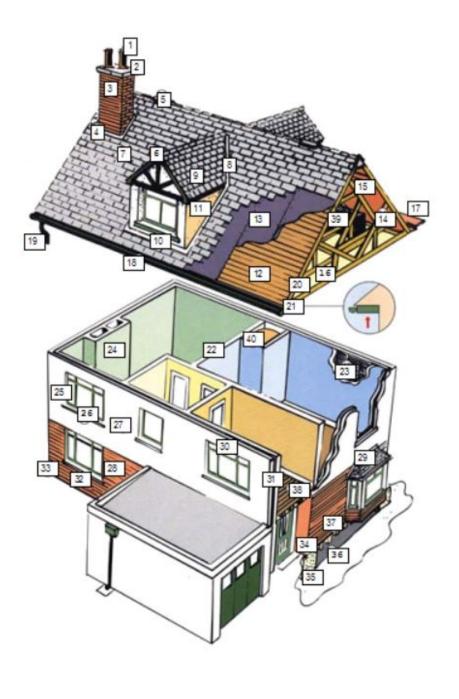
#### Sectional diagram showing elements of a typical house

Chimney pots 1 Coping stone 2 3 Chimney head Flashing 4 Ridge ventilation 5 Ridge board 6 Slates / tiles 7 Valley guttering 8 9 Dormer projection Dormer flashing 10 Dormer cheeks 11 12 Sarking 13 Roof felt Trusses 14 Collar 15 Insulation 16 Parapet gutter 17 18 Eaves guttering Rainwater downpipe 19 20 Verge boards / skews 21 Soffit boards Partition wall 22 23 Lath / plaster 24 Chimney breast Window pointing 25 Window sills 26 Rendering 27 Brickwork / pointing 28 Bay window projection 29 Lintels 30 Cavity walls / wall ties 31 Subfloor ventilator 32 33 Damp proof course Base course 34 Foundations 35 Solum 36 Floor joists 37 Floorboards 38 Water tank 39 Hot water tank 40

Reference may be made in this report to some or all of the above component parts of the property. This diagram may assist you in locating and understanding these items.
