HOME REPORT

FLAT 1
2 JEFFREY STREET
RICCARTON
KILMARNOCK
KA1 4EB

Energy Performance Certificate (EPC)

FLAT 1 , 2 JEFFREY STREET, RICCARTON, KILMARNOCK, KA1 4EB

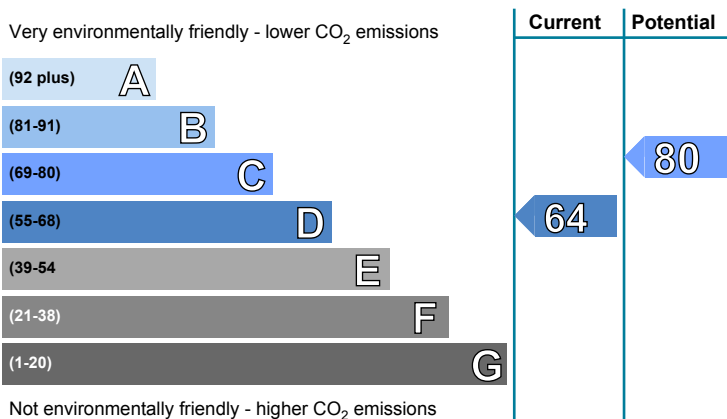
Environmental Impact (CO₂) Rating

This graph shows the effect of your home on the environment in terms of carbon dioxide (CO₂) emissions. The higher the rating, the less impact it has on the environment.

Your current rating is **band D (64)**. The average rating for EPCs in Scotland is **band D (59)**.

The potential rating shows the effect of undertaking all of the improvement measures listed within your recommendations report.
