Home Report

Single Survey

Property address	8 Warrack Street St. Andrews KY16 8DR
Customer	Mrs Pamela Ruschak
Customer address	
Prepared by	Shepherd Chartered Surveyors
Date of inspection	12/02/2025

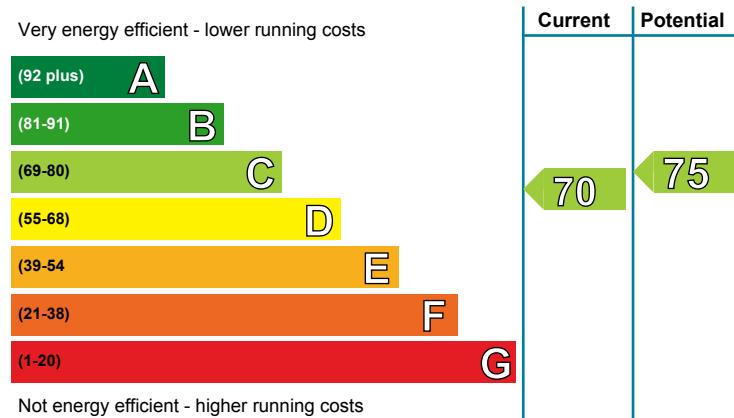
Energy Efficiency Rating

This graph shows the current efficiency of your home, taking into account both energy efficiency and fuel costs. The higher this rating, the lower your fuel bills are likely to be.

Your current rating is **band C (70)**. The average rating for EPCs in Scotland is **band D (61)**.

The potential rating shows the effect of undertaking all of the improvement measures listed within your recommendations report.

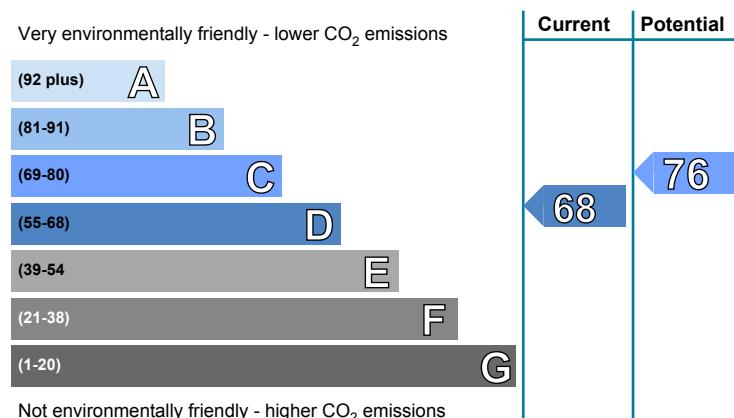
Environmental Impact (CO₂) Rating

This graph shows the effect of your home on the environment in terms of carbon dioxide (CO₂) emissions. The higher the rating, the less impact it has on the environment.
