# Home Report

Falach Fead Templetonburn  
Crookedholm Kilmarnock KA3 6HP

# Single Survey

| <b>Description</b> | The property comprises of a detached two storey chalet style villa. |

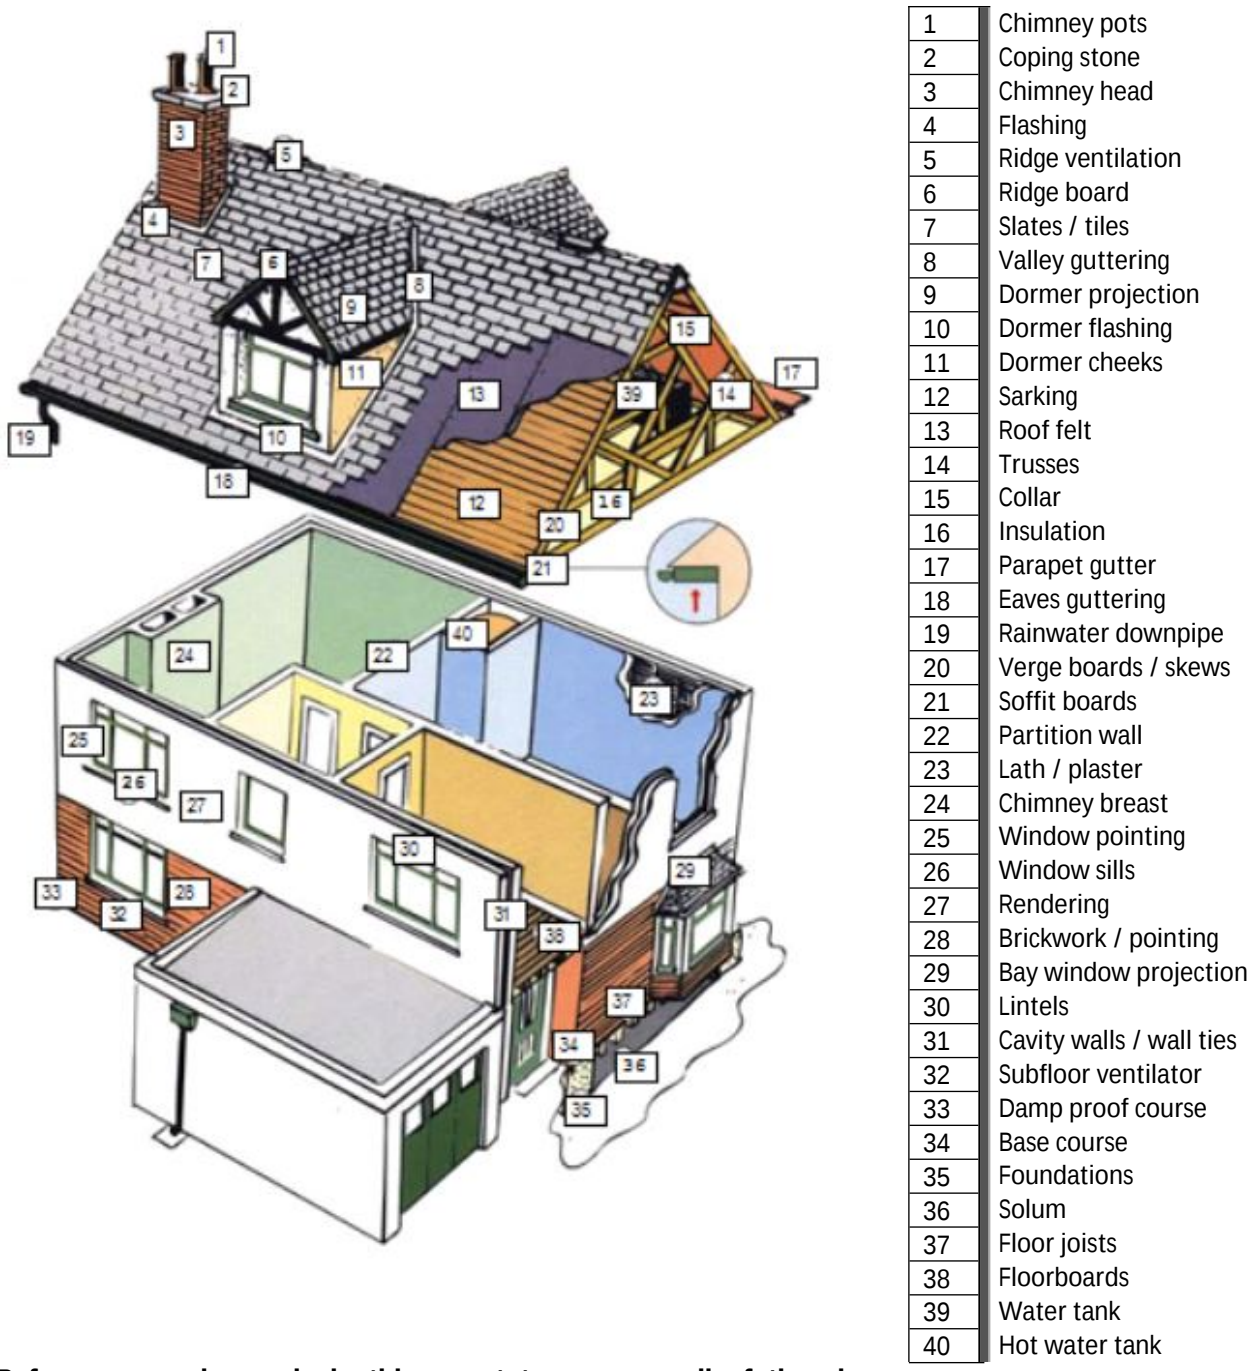
# Sectional diagram showing elements of a typical house

Reference may be made in this report to some or all of the above component parts of the property. This diagram may assist you in locating and understanding these items.
