Home Report

3J Isles Street Newmilns KA16 9DP

single survey

Property address	
	3J Isles Street
	Newmilns
	KA16 9DP

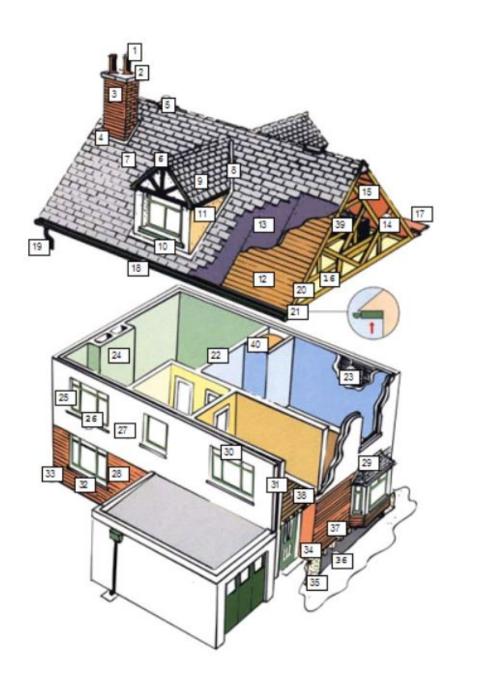
Sectional Diagram showing elements of a typical house

- Chimney pots
- 2 Coping stone
- 3 Chimney head
- Flashing 4
- Ridge ventilation
- Ridge board
- Slates/tiles
- Valley guttering 8
- Dormer projection 9
- 10 Dormer flashing
- 11 Dormer cheeks
- 12 Sarking
- Roof felt 13
- Trusses 14
- 15 Collar
- Insulation 16
- Parapet gutter 17
- Eaves guttering 18
- 19 Rainwater downpipe
- 20 Verge boards / skews
- Soffit boards 21
- Partition wall 22
- Lath / plaster 23
- 24 Chimney breast
- 25 Window pointing
- Window sills
- 26
- Rendering 27
- Brickwork / pointing 28
- window Bay 29
 - projection
- 30 Lintels
- Cavity walls / wall ties 31
- Subfloor ventilator 32
- Damp proof course 33
- Base course 34
- 35 **Foundations**
- Solum 36
- 37 Floor joists
- 38 Floorboards
- 39 Water tank
- 40 Hot water tank

Reference may be made in this report to some or all of the above component parts of the property. This diagram may assist you in locating and understanding these items.
