Home Report

Single Survey

Property address	2 Mull Place Broomlands Irvine KA11 1HP
Customer	Yvonne Dean
Customer address	2 Mull Place Broomlands Irvine KA11 1HP
Prepared by	Shepherd Chartered Surveyors
Date of inspection	05/02/2026

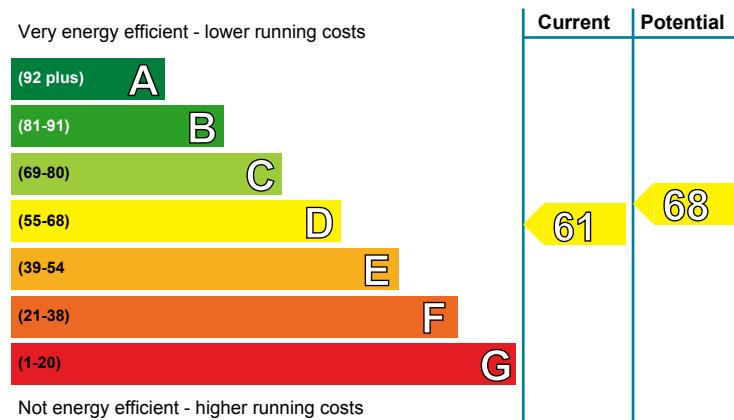
Energy Efficiency Rating

This graph shows the current efficiency of your home, taking into account both energy efficiency and fuel costs. The higher this rating, the lower your fuel bills are likely to be.

Your current rating is **band D (61)**. The average rating for EPCs in Scotland is **band D (61)**.

The potential rating shows the effect of undertaking all of the improvement measures listed within your recommendations report.

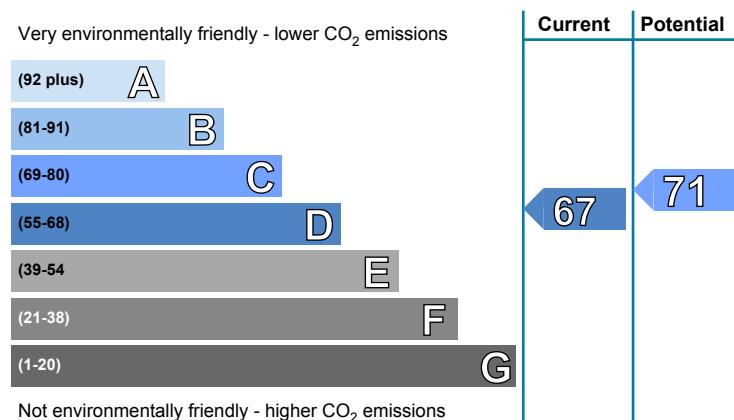
Environmental Impact (CO₂) Rating

This graph shows the effect of your home on the environment in terms of carbon dioxide (CO₂) emissions. The higher the rating, the less impact it has on the environment.
