Energy Performance Certificate (EPC)

FLAT 13 , 1 CRAIGMOUNT COURT, CRAIGMOUNT, EDINBURGH, EH4 8HL

Dwelling type:	Mid-floor maisonette	Reference number:	9481-1001-2208-1092-3204
Date of assessment:	18 August 2022	Type of assessment:	RdSAP, existing dwelling
Date of certificate:	18 August 2022	Approved Organisation:	Elmhurst
Total floor area:	90 m ²	Main heating and fuel:	Boiler and radiators, electric
Primary Energy Indicator:	431 kWh/m ² /year

Single Survey

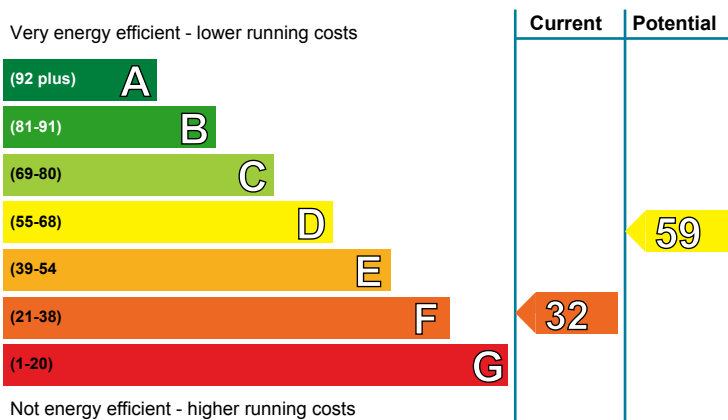
Energy Efficiency Rating

This graph shows the current efficiency of your home, taking into account both energy efficiency and fuel costs. The higher this rating, the lower your fuel bills are likely to be.

Your current rating is **band F (32)**. The average rating for EPCs in Scotland is **band D (61)**.

The potential rating shows the effect of undertaking all of the improvement measures listed within your recommendations report.

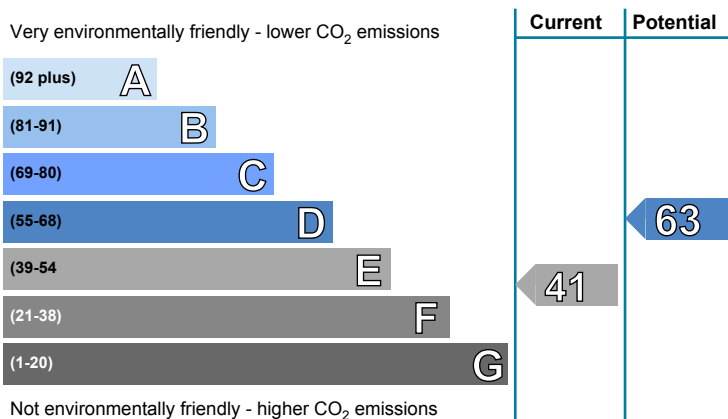
Environmental Impact (CO₂) Rating

This graph shows the effect of your home on the environment in terms of carbon dioxide (CO₂) emissions. The higher the rating, the less impact it has on the environment.

The potential rating shows the effect of undertaking all of the improvement measures listed within your recommendations report.
