# Single Survey

<b>Property address</b>	2 Hadden Farm Cottages Kelso TD5 8HU
<b>Customer</b>	Ms Zena McFadzean & Mr Iain Fullarton
<b>Customer address</b>	2 Hadden Farm Cottages Kelso TD5 8HU
<b>Prepared by</b>	Shepherd Chartered Surveyors
<b>Date of inspection</b>	01/05/2025

## Sectional Diagram showing elements of a typical house

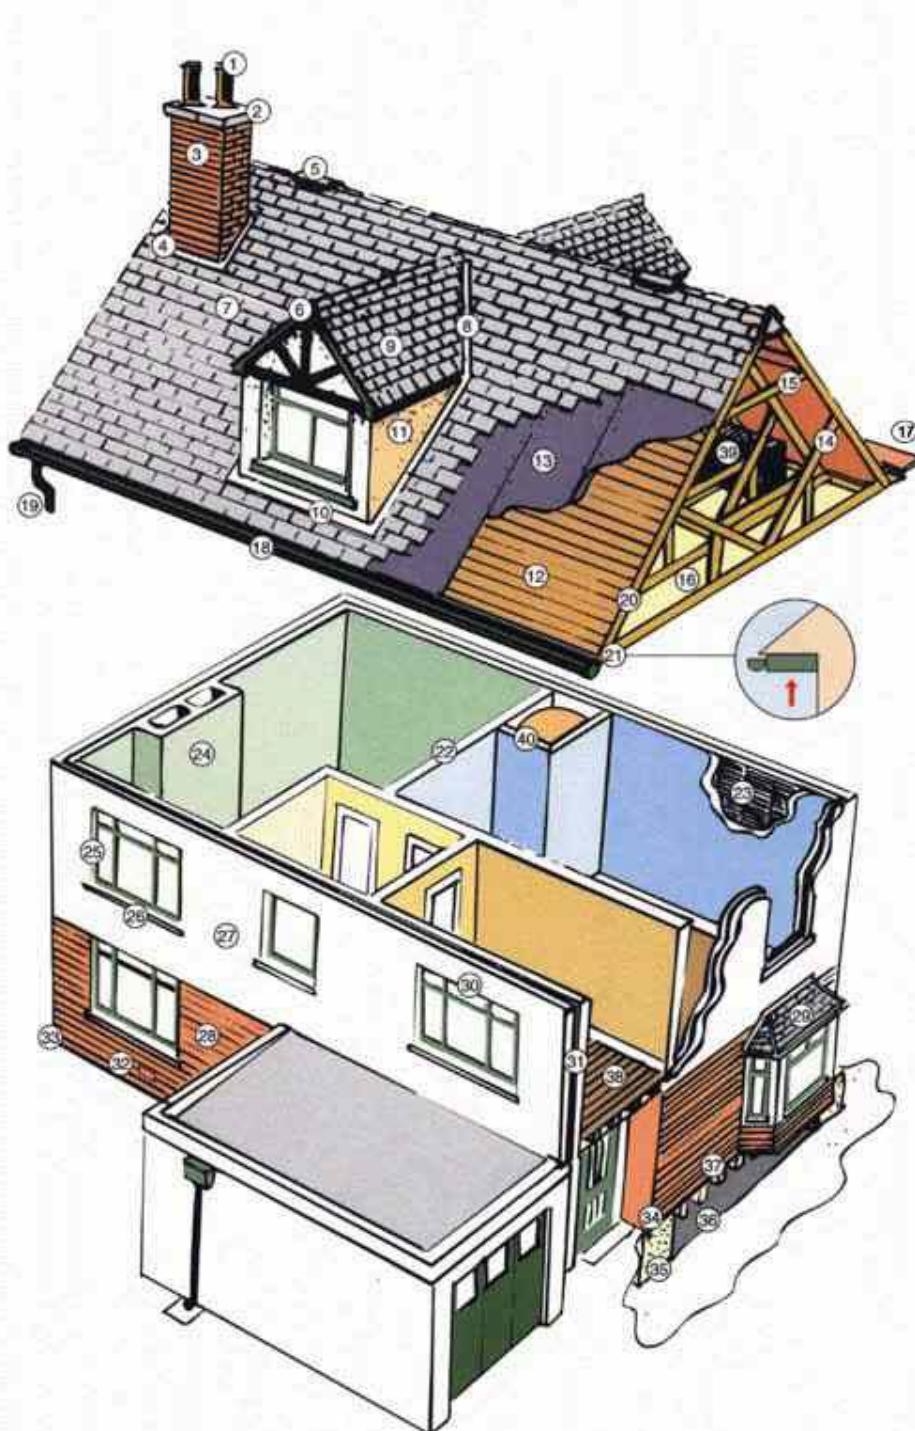
- 1 Chimney pots
- 2 Coping stone
- 3 Chimney head
- 4 Flashing
- 5 Ridge ventilation
- 6 Ridge board
- 7 Slates / tiles
- 8 Valley guttering
- 9 Dormer projection
- 10 Dormer flashing
- 11 Dormer cheeks
- 12 Sarking
- 13 Roof felt
- 14 Trusses
- 15 Collar
- 16 Insulation
- 17 Parapet gutter
- 18 Eaves guttering
- 19 Rainwater downpipe
- 20 Verge boards /skews
- 21 Soffit boards
- 22 Partition wall
- 23 Lath / plaster
- 24 Chimney breast
- 25 Window pointing
- 26 Window sills
- 27 Rendering
- 28 Brickwork / pointing
- 29 Bay window projection
- 30 Lintels
- 31 Cavity walls / wall ties
- 32 Subfloor ventilator
- 33 Damp proof course
- 34 Base course
- 35 Foundations
- 36 Solum
- 37 Floor joists
- 38 Floorboards
- 39 Water tank
- 40 Hot water tank

Reference may be made in this report to some or all of the above component parts of the property. This diagram may assist you in locating and understanding these items.
