HOME REPORT

27 FOREST GROVE
BEANSBURN
KILMARNOCK
KA3 1UP

Single Survey

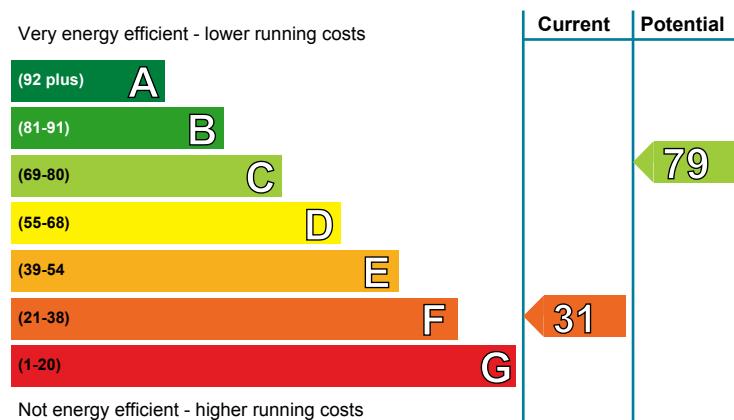
Energy Efficiency Rating

This graph shows the current efficiency of your home, taking into account both energy efficiency and fuel costs. The higher this rating, the lower your fuel bills are likely to be.

Your current rating is **band F (31)**. The average rating for EPCs in Scotland is **band D (61)**.

The potential rating shows the effect of undertaking all of the improvement measures listed within your recommendations report.

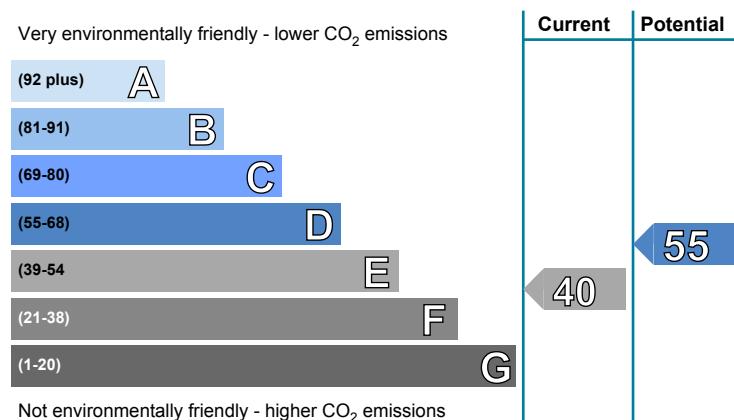
Environmental Impact (CO₂) Rating

This graph shows the effect of your home on the environment in terms of carbon dioxide (CO₂) emissions. The higher the rating, the less impact it has on the environment.

Your current rating is **band E (40)**. The average rating for EPCs in Scotland is **band D (59)**.

The potential rating shows the effect of undertaking all of the improvement measures listed within your recommendations report.
