HARVEY DONALDSON & GIBSON

Survey report on:

Property Address	Ardoch Mill Deskford Buckie AB56 5XX
Customer	Mr D Macgregor & Mrs L Macgregor
Date of Inspection	24/04/2024
Prepared by	Kenneth J Silver Harvey Donaldson & Gibson Chartered Surveyors

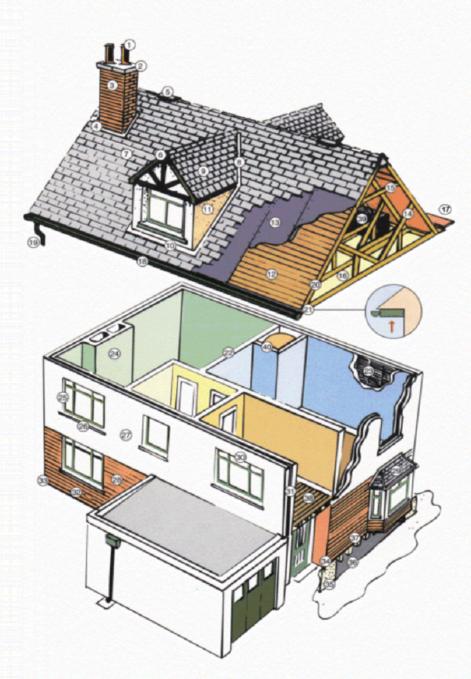
Sectional Diagram showing elements of a typical house

Reference may be made in this report to some or all of the above component parts of the property. This diagram may assist you in locating and understanding these items.

- 1 Chimney pots
- 2 Coping stone
- 3) Chimney head
- 4 Flashing
- 5) Ridge ventilation
- 6 Ridge board
- 7 Slates / tiles
- 8 Valley guttering
- Dormer projection
- 10 Dormer flashing
- 11 Dormer cheeks
- 12) Sarking
- 13) Roof felt
- 14) Trusses
- (15) Collar
- 16 Insulation
- 17) Parapet gutter
- 18) Eaves guttering
- (19) Rainwater downpipe
- 20 Verge boards /skews
- (21) Soffit boards
- 22) Partition wall
- 23 Lath / plaster
- 24) Chimney breast
- 25 Window pointing
- (26) Window sills
- (27) Rendering
- (28) Brickwork / pointing
- 29 Bay window projection
- 30 Lintels
- 31) Cavity walls / wall ties
- 32) Subfloor ventilator
- 33 Damp proof course
- 34) Base course
- 35) Foundations
- 36) Solum
- (37) Floor joists
- (38) Floorboards
- 39) Water tank
- (40) Hot water tank
