Home Report

24 Luce Avenue
Kilmarnock
KA1 3PE

single survey

survey report on:

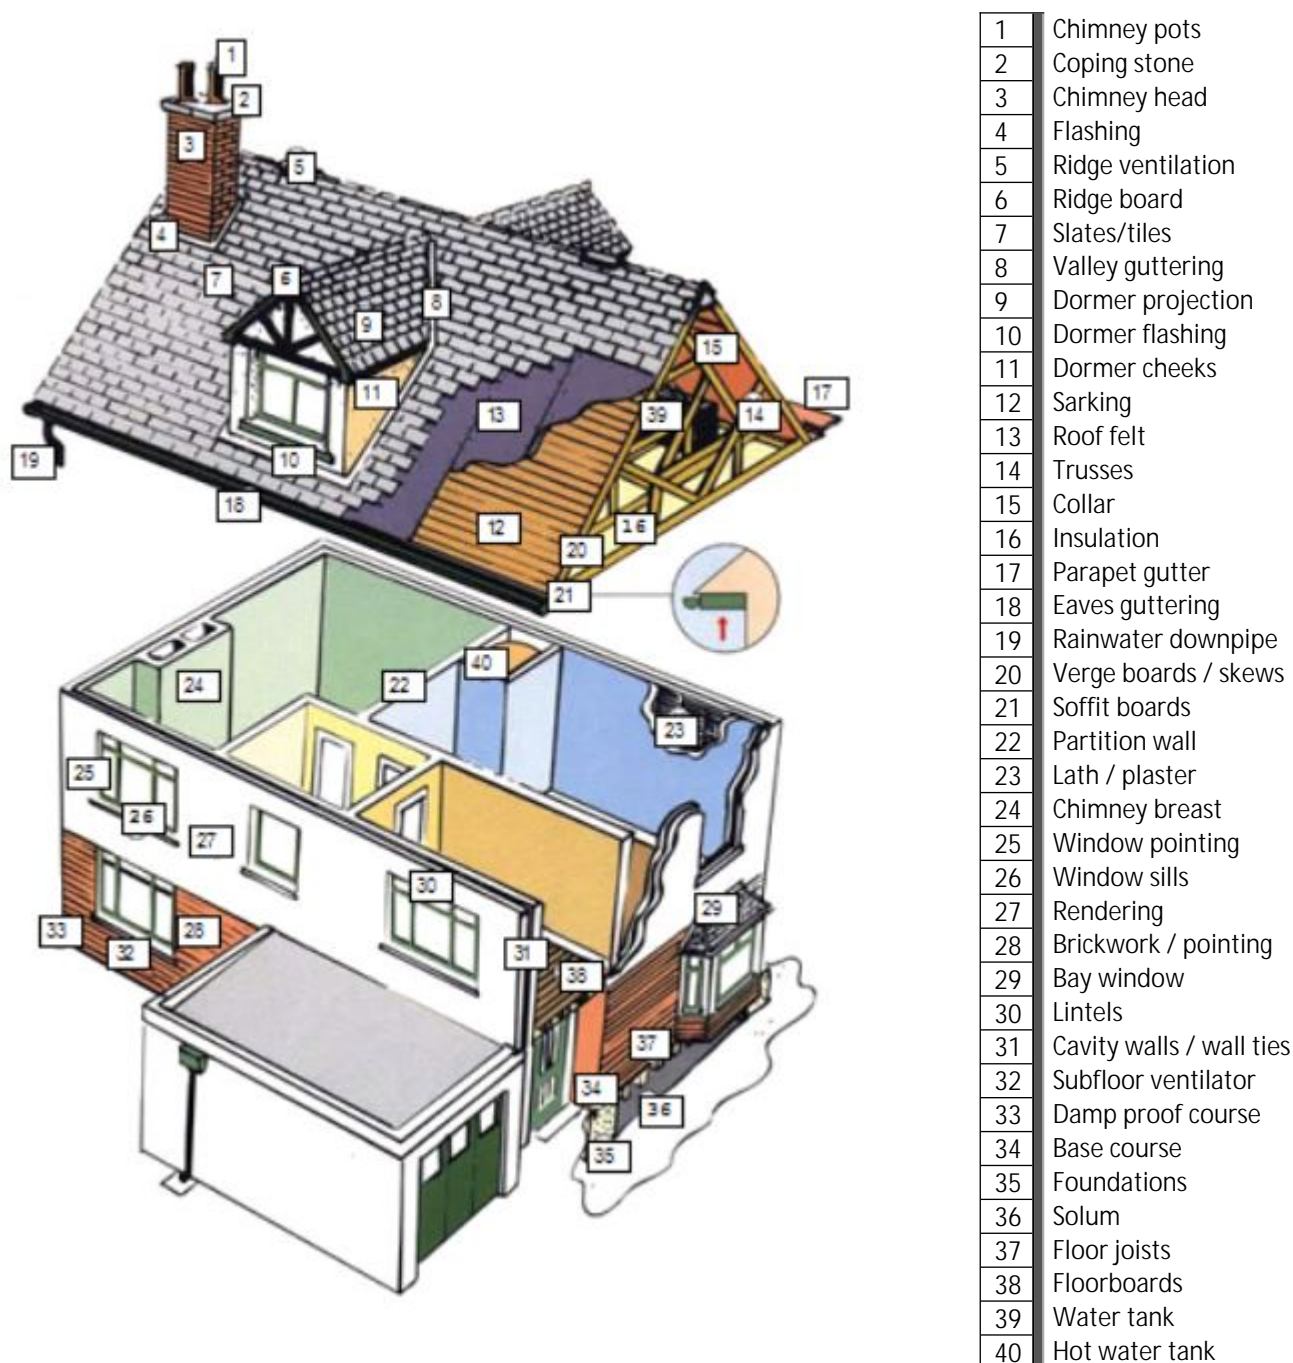
Sectional Diagram showing elements of a typical house

Reference may be made in this report to some or all of the above component parts of the property. This diagram may assist you in locating and understanding these items.
