Home Report

Property address	Birchwood Campmuir Coupar Angus Blairgowrie PH13 9LN
Seller(s)	Mr Peter Mason
Completion date of property questionnaire	01/07/2023

Property address	Birchwood Campmuir Coupar Angus Blairgowrie PH13 9LN
Customer	Mr Peter Mason
Customer address	Birchwood Campmuir Coupar Angus Blairgowrie PH13 9LN
Prepared by	Shepherd Chartered Surveyors
Date of inspection	06/07/2023

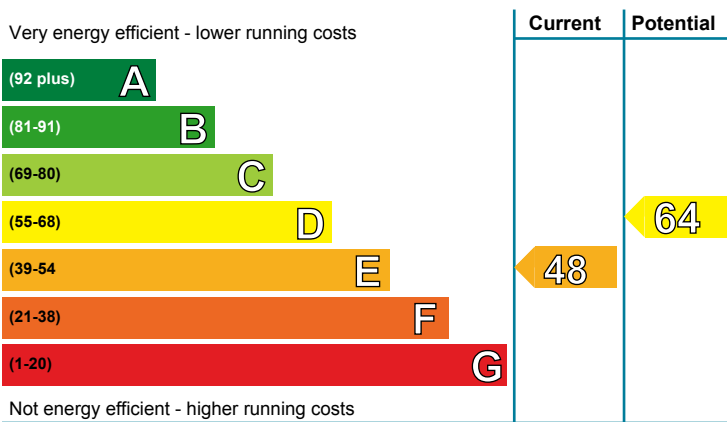
Energy Efficiency Rating

This graph shows the current efficiency of your home, taking into account both energy efficiency and fuel costs. The higher this rating, the lower your fuel bills are likely to be.

Your current rating is **band E (48)**. The average rating for EPCs in Scotland is **band D (61)**.

The potential rating shows the effect of undertaking all of the improvement measures listed within your recommendations report.

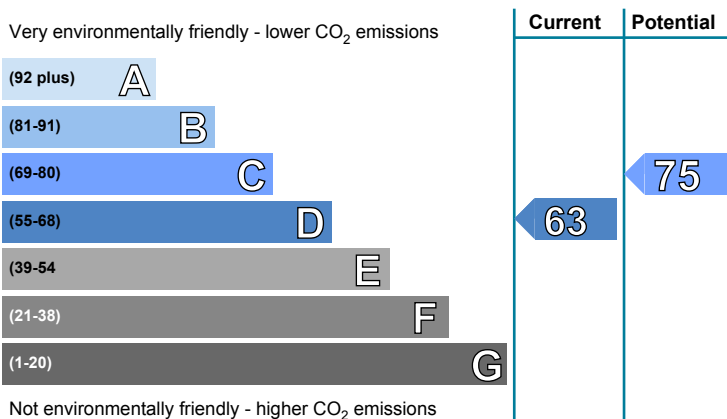
Environmental Impact (CO₂) Rating

This graph shows the effect of your home on the environment in terms of carbon dioxide (CO₂) emissions. The higher the rating, the less impact it has on the environment.

The potential rating shows the effect of undertaking all of the improvement measures listed within your recommendations report.
