# Home Report

# Scottish Single Survey

<b>Property address</b>	21 Woodstock Street Kilmarnock KA1 2BE
<b>Customer</b>	Nicola Auchie & Jamie Neilson
<b>Customer address</b>	21 Woodstock Street Kilmarnock KA1 2BE
<b>Prepared by</b>	Shepherd Chartered Surveyors
<b>Date of inspection</b>	29/12/2025

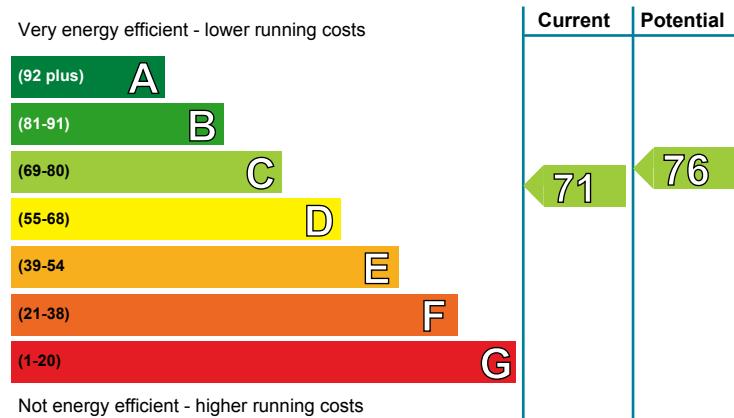
## Energy Efficiency Rating

This graph shows the current efficiency of your home, taking into account both energy efficiency and fuel costs. The higher this rating, the lower your fuel bills are likely to be.

Your current rating is **band C (71)**. The average rating for EPCs in Scotland is **band D (61)**.

The potential rating shows the effect of undertaking all of the improvement measures listed within your recommendations report.

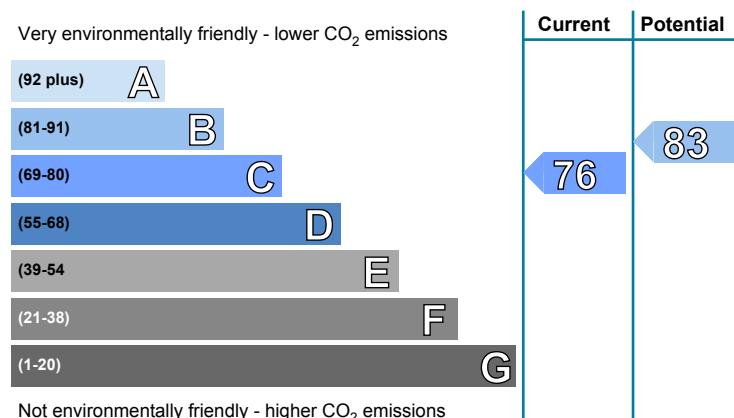
## Environmental Impact (CO<sub>2</sub>) Rating

This graph shows the effect of your home on the environment in terms of carbon dioxide (CO<sub>2</sub>) emissions. The higher the rating, the less impact it has on the environment.
