Flat 18
Erskine Beveridge Court
St. Leonards Street
Dunfermline
KY11 3AW
18/02/2026

Home Report

Scottish Single Survey

Property address	Flat 18 Erskine Beveridge Court St. Leonards Street Dunfermline KY11 3AW
Customer	Sarah Fearnley
Customer address	
Prepared by	Shepherd Chartered Surveyors
Date of inspection	13/02/2026

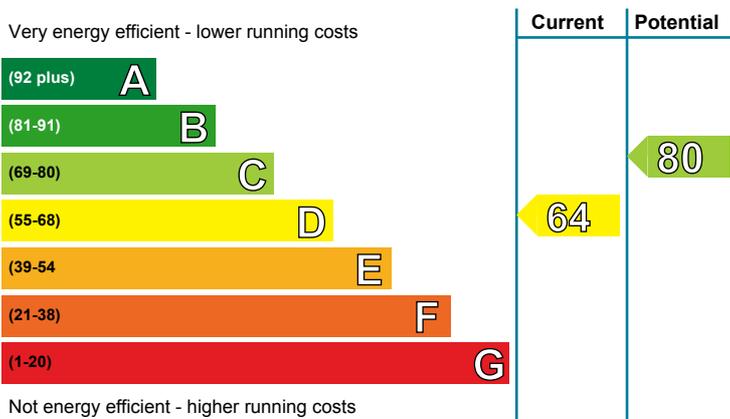
Energy Efficiency Rating

This graph shows the current efficiency of your home, taking into account both energy efficiency and fuel costs. The higher this rating, the lower your fuel bills are likely to be.

Your current rating is **band D (64)**. The average rating for EPCs in Scotland is **band D (61)**.

The potential rating shows the effect of undertaking all of the improvement measures listed within your recommendations report.

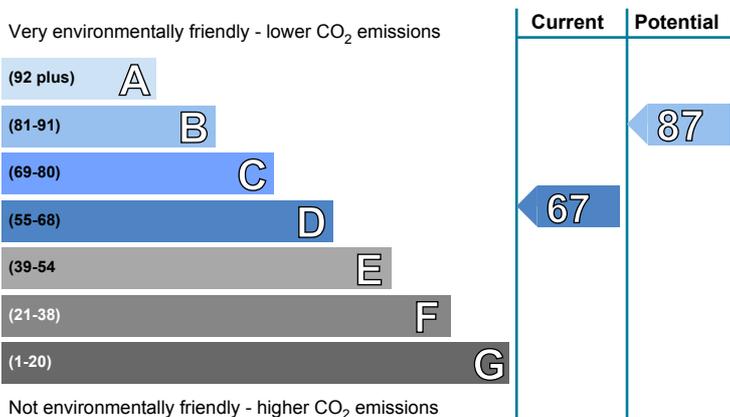
Environmental Impact (CO₂) Rating

This graph shows the effect of your home on the environment in terms of carbon dioxide (CO₂) emissions. The higher the rating, the less impact it has on the environment.
