# Home Report

17C High Street  
Newmilns KA16 9EE

# single survey

<b>Property address</b>	17C High Street Newmilns KA16 9EE
<b>Customer</b>	Norman Phillips
<b>Prepared by</b>	Graham + Sibbald LLP

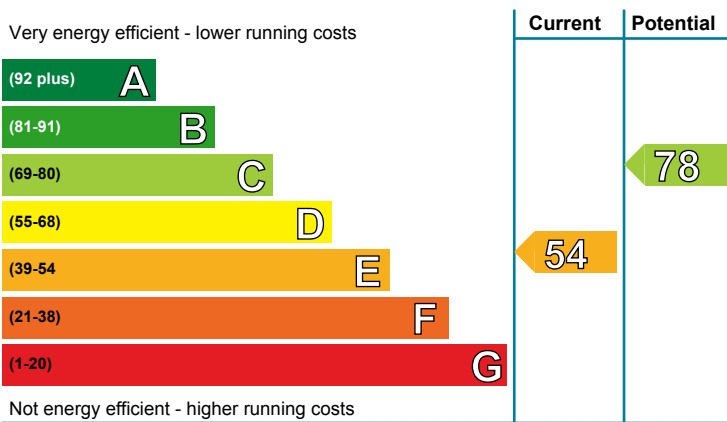
## Energy Efficiency Rating

This graph shows the current efficiency of your home, taking into account both energy efficiency and fuel costs. The higher this rating, the lower your fuel bills are likely to be.

Your current rating is **band E (54)**. The average rating for EPCs in Scotland is **band D (61)**.

The potential rating shows the effect of undertaking all of the improvement measures listed within your recommendations report.

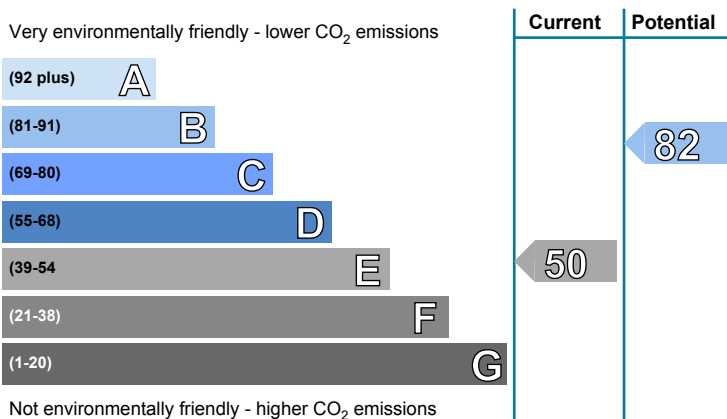
## Environmental Impact (CO<sub>2</sub>) Rating

This graph shows the effect of your home on the environment in terms of carbon dioxide (CO<sub>2</sub>) emissions. The higher the rating, the less impact it has on the environment.
