YOUR ONESURVEY
HOME REPORT

475 Main Street
Coatbridge
ML5 3RD

SINGLE SURVEY

Single Survey

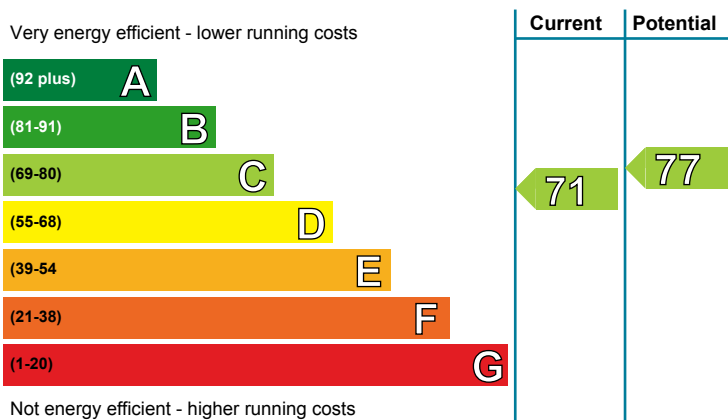
Energy Efficiency Rating

This graph shows the current efficiency of your home, taking into account both energy efficiency and fuel costs. The higher this rating, the lower your fuel bills are likely to be.

Your current rating is **band C (71)**. The average rating for EPCs in Scotland is **band D (61)**.

The potential rating shows the effect of undertaking all of the improvement measures listed within your recommendations report.
