HOME REPORT

25 RANKEN DRIVE IRVINE KA12 0QX

SINGLE SURVEY

survey report on:

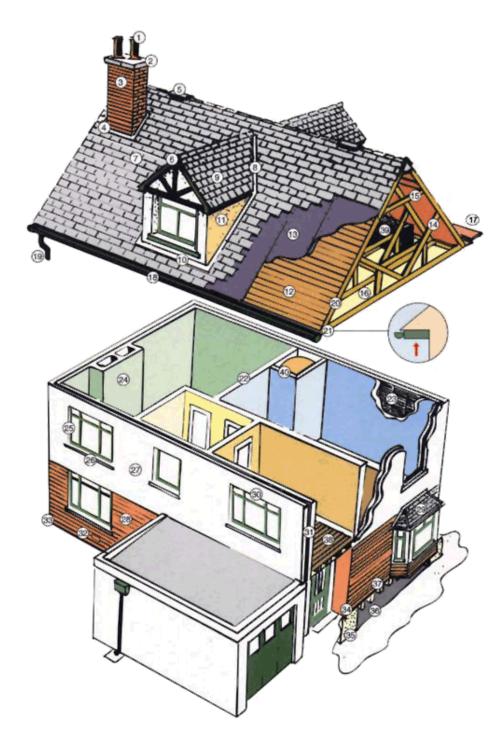
Sectional Diagram showing elements of a typical house

Reference may be made in this report to some or all of the above component parts of the property. This diagram may assist you in locating and understanding these items.

- 1) Chimney pots
- 2) Coping stone
- 3) Chimney head
- 4 Flashing
- 5) Ridge ventilation
- 6 Ridge board
- 7) Slates / tiles
- 8 Valley guttering
- 9 Dormer projection
- 10 Dormer flashing
- 11) Dormer cheeks
- (12) Sarking
- (13) Roof felt
- (14) Trusses
- (15) Collar
- 16 Insulation
- 17) Parapet gutter
- (18) Eaves guttering
- 19) Rainwater downpipe
- 20) Verge boards /skews
- 21) Soffit boards
- 22) Partition wall
- 23) Lath / plaster
- 24) Chimney breast
- (25) Window pointing
- 6) Window sills
- 27) Rendering
- (28) Brickwork / pointing
- 29) Bay window projection
- 30 Lintels
- (31) Cavity walls / wall ties
- 32) Subfloor ventilator
- 33 Damp proof course
- 34) Base course
- (35) Foundations
- 36) Solum
- 37) Floor joists
- 38) Floorboards
- 39) Water tank
- 40 Hot water tank
