# YOUR ONESURVEY HOME REPORT

79c Drip Road  
Stirling  
FK8 1RN

# SINGLE SURVEY

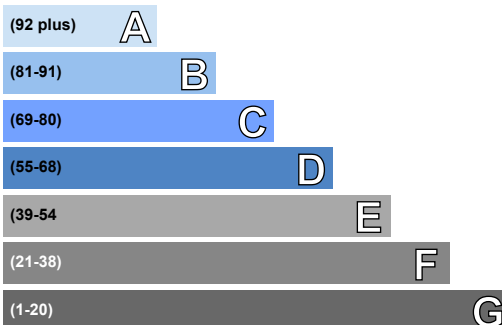
Very environmentally friendly - lower CO<sub>2</sub> emissions

| Current | Potential |
| 83 | 83 |
