Home Report

The Sheiling

single survey

Property address	The Sheiling
	Maybole KA19 7QQ

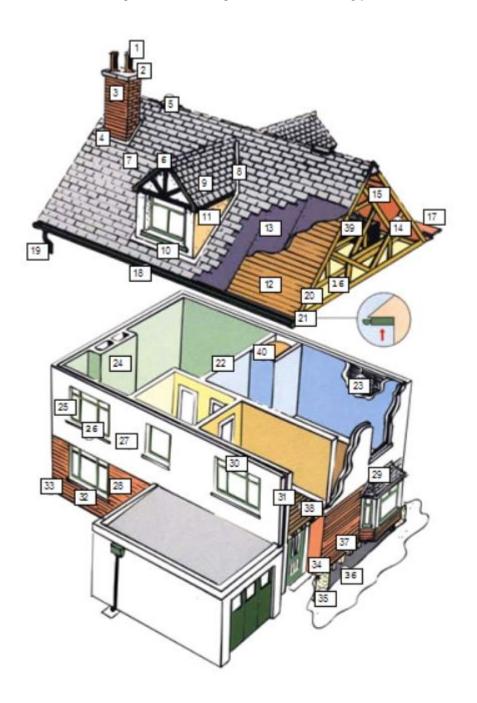
Sectional Diagram showing elements of a typical house

Ridge board Slates/tiles 8 Valley guttering 9 Dormer projection Dormer flashing 10 Dormer cheeks 11 12 Sarking Roof felt 13 Trusses 14 15 Collar 16 Insulation 17 Parapet gutter Eaves guttering 18 Rainwater downpipe 19 20 Verge boards / skews 21 Soffit boards 22 Partition wall Lath / plaster 23 24 Chimney breast 25 Window pointing Window sills 26 Rendering 27
