YOUR ONESURVEY HOME REPORT

11 The Forge Dunfermline KY12 9ED

Single Survey

Date of Inspection	02/05/2025
Prepared by	Jonathan Combe, BSc (Hons) MRICS
	Dunfermline - Allied Surveyors Scotland Ltd

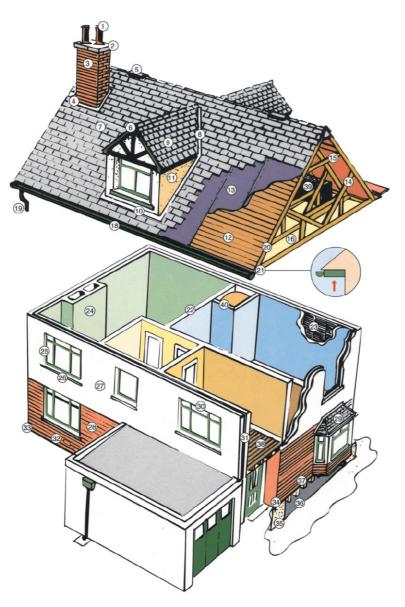
Sectional Diagram showing elements of a typical house

Reference may be made in this report to some or all of the above component parts of the property. This diagram may assist you in locating and understanding these items.
