HOME REPORT

8 INCH VIEW
KINGHORN
BURNTISLAND
KY3 9SH

Energy Performance Certificate (EPC)

8 INCH VIEW, KINGHORN, BURNTISLAND, KY3 9SH

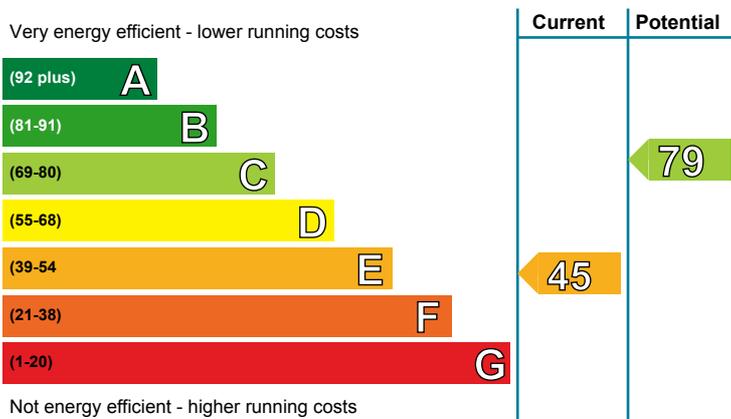
Energy Efficiency Rating

This graph shows the current efficiency of your home, taking into account both energy efficiency and fuel costs. The higher this rating, the lower your fuel bills are likely to be.

Your current rating is **band E (45)**. The average rating for EPCs in Scotland is **band D (61)**.

The potential rating shows the effect of undertaking all of the improvement measures listed within your recommendations report.

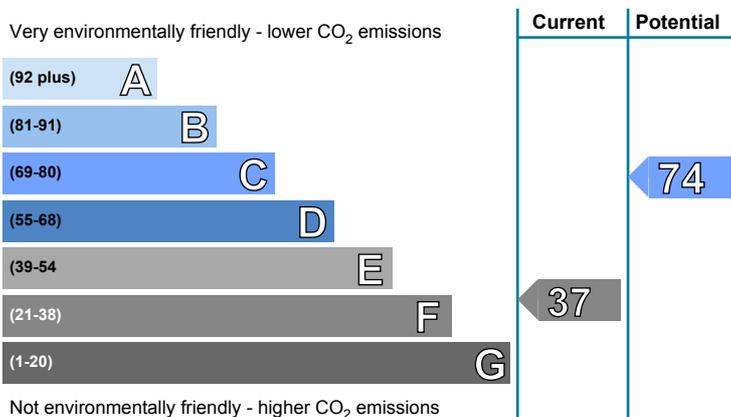
Environmental Impact (CO₂) Rating

This graph shows the effect of your home on the environment in terms of carbon dioxide (CO₂) emissions. The higher the rating, the less impact it has on the environment.

Your current rating is **band F (37)**. The average rating for EPCs in Scotland is **band D (59)**.

The potential rating shows the effect of undertaking all of the improvement measures listed within your recommendations report.
