Home Report

Scottish
Single Survey

survey report on:

Property address	11 Craigmark Place Girdle Toll Irvine KA11 1BJ
Customer	Mrs Lynn Smith
Customer address	11 Craigmark Place Girdle Toll Irvine KA11 1BJ
Prepared by	Shepherd Chartered Surveyors
Date of inspection	24/12/2024

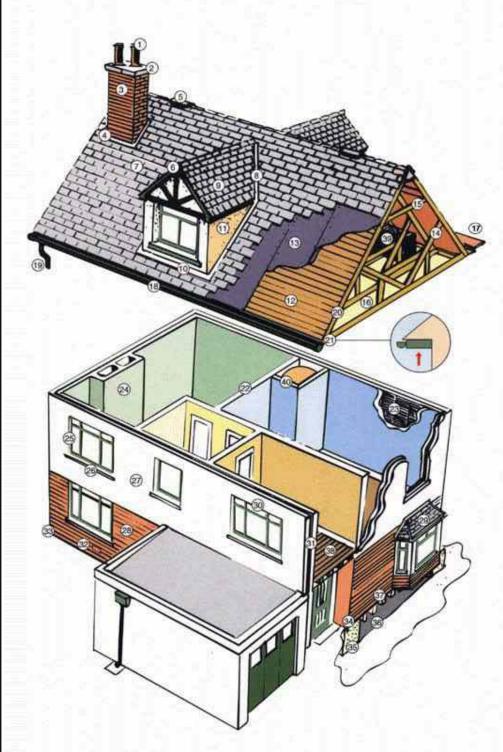
Sectional Diagram showing elements of a typical house

Reference may be made in this report to some or all of the above component parts of the property. This diagram may assist you in locating and understanding these items.

- 1) Chimney pots
- 2) Coping stone
- 3 Chimney head
- (4) Flashing
- 5) Ridge ventilation
- 6 Ridge board
- 7 Slates / tiles
- 8 Valley guttering
- 9 Dormer projection
- 10 Dormer flashing
- 11 Dormer cheeks
- (12) Sarking
- 13) Roof felt
- (14) Trusses
- (15) Collar
- 16) Insulation
- (17) Parapet gutter
- (18) Eaves guttering
- 19 Rainwater downpipe
- 20) Verge boards/skews
- 21) Soffit boards
- 22) Partition wall
- 23) Lath / plaster
- 24) Chimney breast
- 25) Window pointing
- 26) Window sills
- 27) Rendering
- (28) Brickwork / pointing
- (29) Bay window projection
- (30) Lintels
- (31) Cavity walls / wall ties
- 32) Subfloor ventilator
- (33) Damp proof course
- 34) Base course
- 35) Foundations
- 36) Solum
- 37) Floor joists
- 8) Floorboards
- 9) Water tank
- 40) Hot water tank
