HOME REPORT

75 SOUTH BROOMAGE AVENUE
LARBERT
FK5 3ED

Single Survey

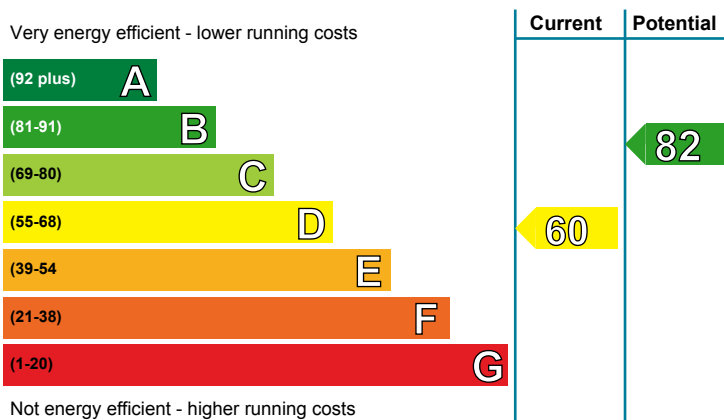
Energy Efficiency Rating

This graph shows the current efficiency of your home, taking into account both energy efficiency and fuel costs. The higher this rating, the lower your fuel bills are likely to be.

Your current rating is **band D (60)**. The average rating for EPCs in Scotland is **band D (61)**.

The potential rating shows the effect of undertaking all of the improvement measures listed within your recommendations report.

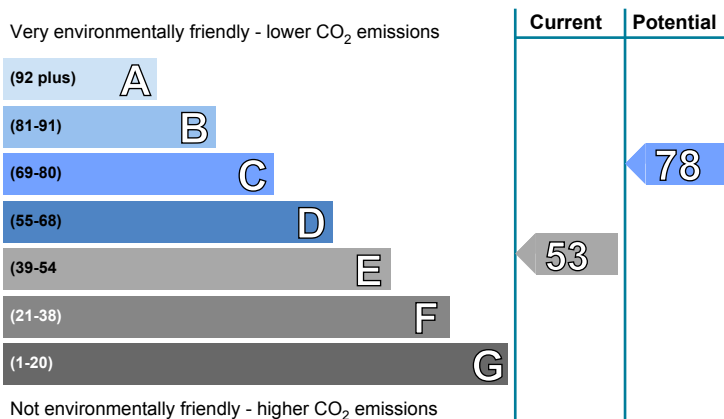
Environmental Impact (CO₂) Rating

This graph shows the effect of your home on the environment in terms of carbon dioxide (CO₂) emissions. The higher the rating, the less impact it has on the environment.

Your current rating is **band E (53)**. The average rating for EPCs in Scotland is **band D (59)**.

The potential rating shows the effect of undertaking all of the improvement measures listed within your recommendations report.
