Energy Performance Certificate (EPC)

150 LINTBURN STREET, GALASHIELS, TD1 1HR

Single Survey

Property address	150 LINTBURN STREET GALASHIELS SCOTTISH BORDERS TD1 1HR
Customer	I DENNISON
Customer address	
Prepared by	Home Report Company
Date of Inspection	5 TH AUGUST 2022

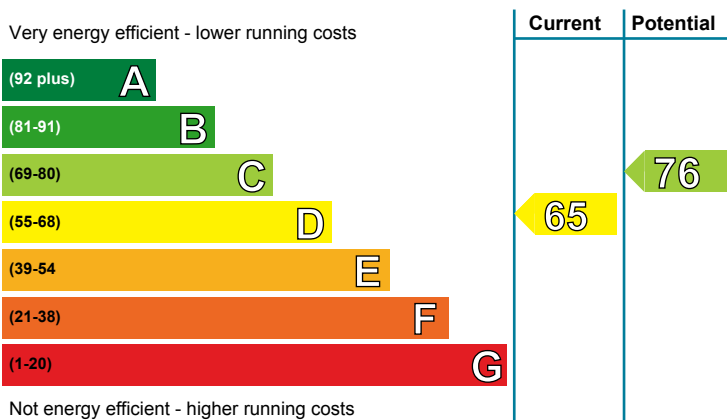
Energy Efficiency Rating

This graph shows the current efficiency of your home, taking into account both energy efficiency and fuel costs. The higher this rating, the lower your fuel bills are likely to be.

Your current rating is **band D (65)**. The average rating for EPCs in Scotland is **band D (61)**.

The potential rating shows the effect of undertaking all of the improvement measures listed within your recommendations report.

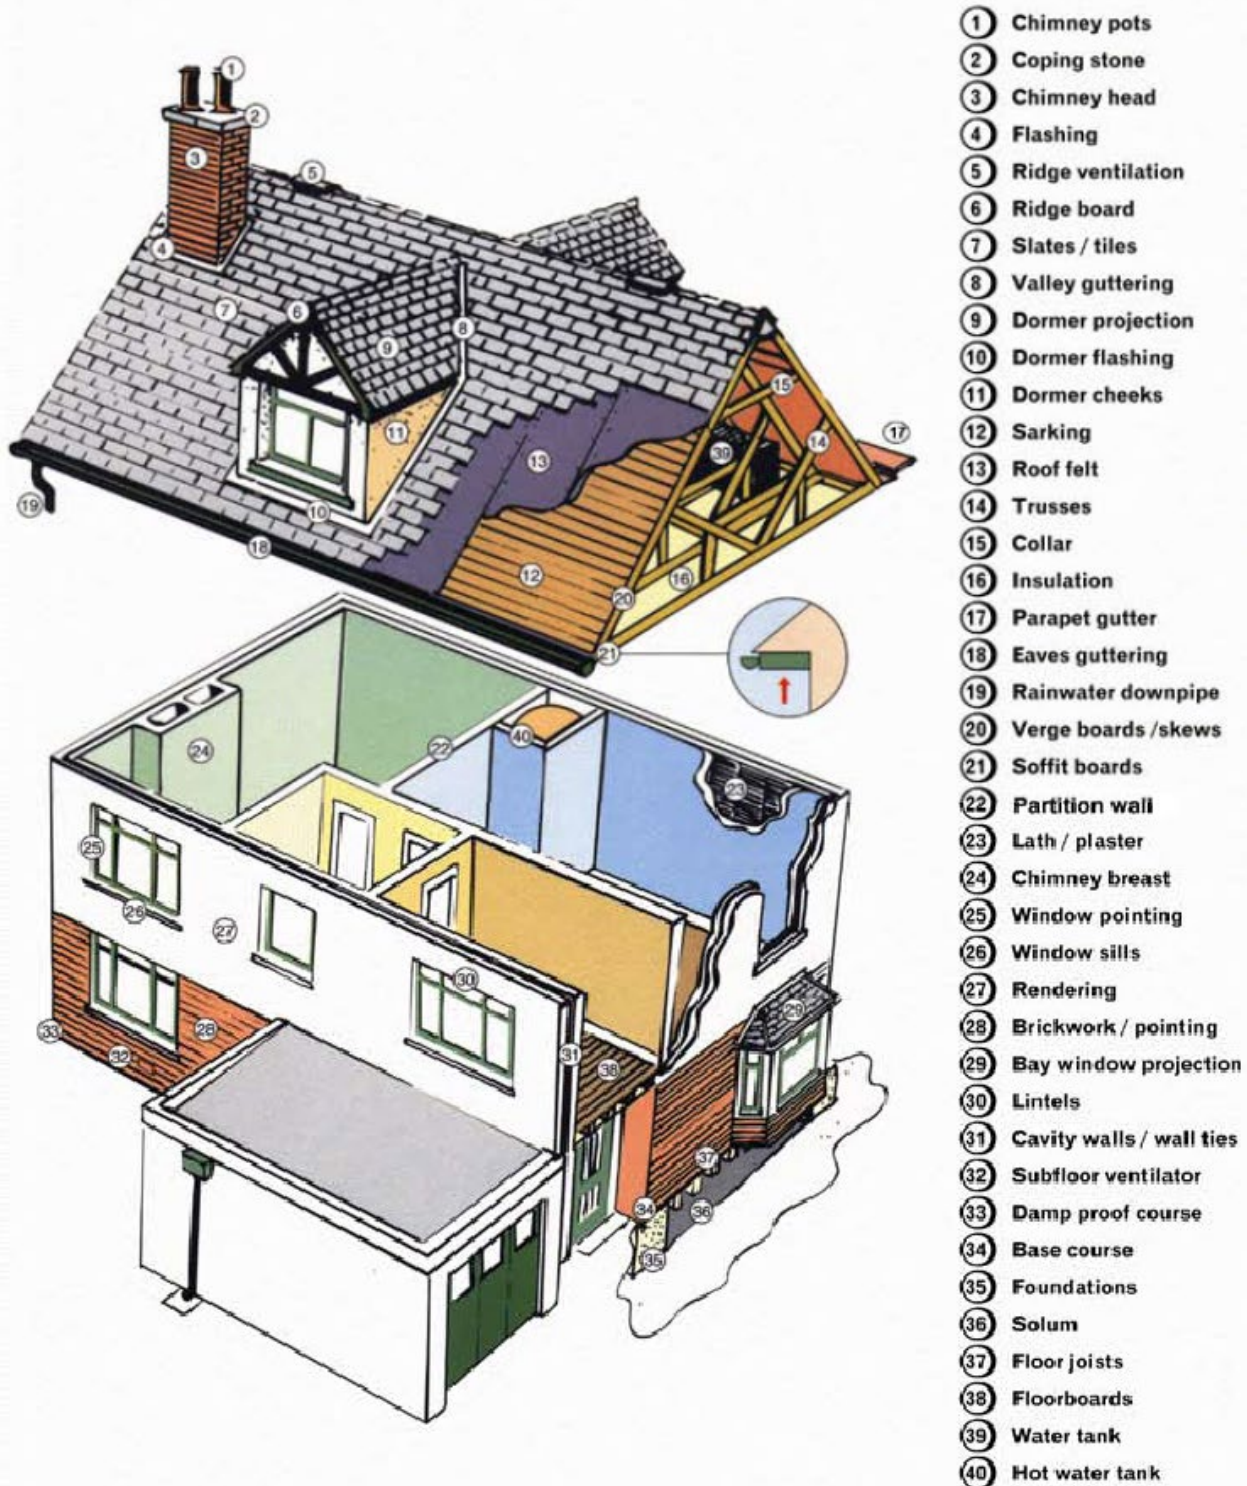
Sectional Diagram showing elements of a typical house

- ① Chimney pots
- ② Coping stone
- ③ Chimney head
- ④ Flashing
- ⑤ Ridge ventilation
- ⑥ Ridge board
- ⑦ Slates / tiles
- ⑧ Valley guttering
- ⑨ Dormer projection
- ⑩ Dormer flashing
- ⑪ Dormer cheeks
- ⑫ Sarking
- ⑬ Roof felt
- ⑭ Trusses
- ⑮ Collar
- ⑯ Insulation
- ⑰ Parapet gutter
- ⑱ Eaves guttering
- ⑲ Rainwater downpipe
- ⑳ Verge boards /skews
- ㉑ Soffit boards
- ㉒ Partition wall
- ㉓ Lath / plaster
- ㉔ Chimney breast
- ㉕ Window pointing
- ㉖ Window sills
- ㉗ Rendering
- ㉘ Brickwork / pointing
- ㉙ Bay window projection
- ㉚ Lintels
- ㉛ Cavity walls / wall ties
- ㉜ Subfloor ventilator
- ㉝ Damp proof course
- ㉞ Base course
- ㉟ Foundations
- ㊱ Solum
- ㊲ Floor joists
- ㊳ Floorboards
- ㊴ Water tank
- ㊵ Hot water tank

Reference may be made in this report to some or all of the above component parts of the property. This diagram may assist you in locating and understanding these items.
