HOME REPORT

LAVENDER COTTAGE SOUTH STREET

FALKLAND
CUPAR
KY15 7AT

Energy Performance Certificate (EPC)

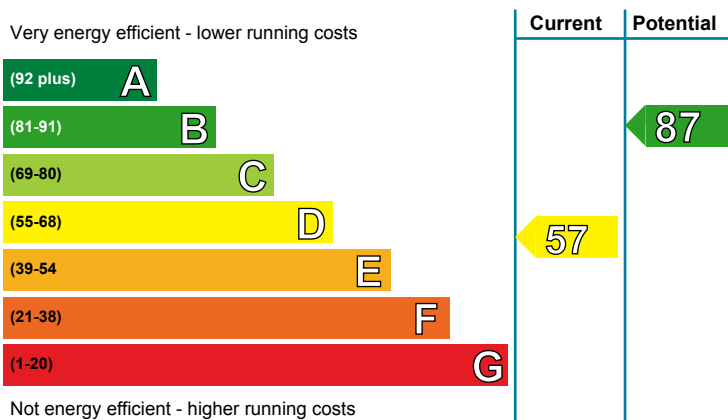
Energy Efficiency Rating

This graph shows the current efficiency of your home, taking into account both energy efficiency and fuel costs. The higher this rating, the lower your fuel bills are likely to be.

Your current rating is **band D (57)**. The average rating for EPCs in Scotland is **band D (61)**.

The potential rating shows the effect of undertaking all of the improvement measures listed within your recommendations report.

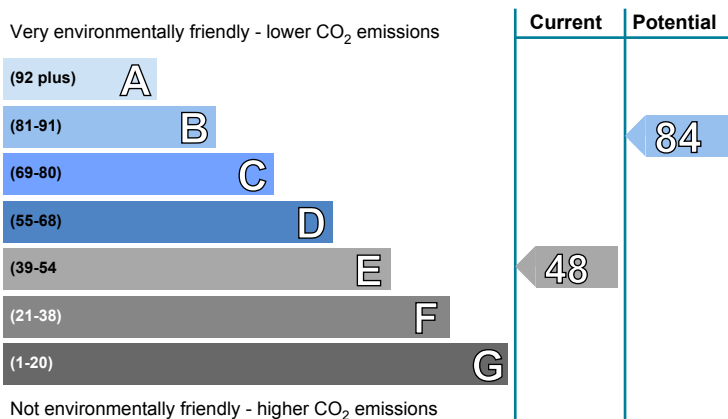
Environmental Impact (CO₂) Rating

This graph shows the effect of your home on the environment in terms of carbon dioxide (CO₂) emissions. The higher the rating, the less impact it has on the environment.

Your current rating is **band E (48)**. The average rating for EPCs in Scotland is **band D (59)**.

The potential rating shows the effect of undertaking all of the improvement measures listed within your recommendations report.
