# Scottish Single Survey

Property address	136 Woodmill Crescent Dunfermline KY11 4AJ
------------------	--

Prepared by	Shepherd Chartered Surveyors
-------------	------------------------------

Date of inspection	16/01/2025

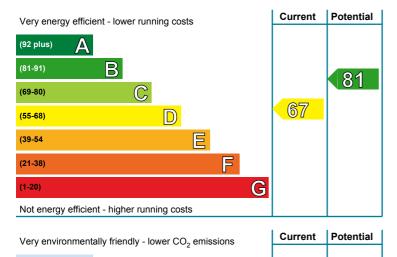
# **Energy Efficiency Rating**

This graph shows the current efficiency of your home, taking into account both energy efficiency and fuel costs. The higher this rating, the lower your fuel bills are likely to be.
