Home Report

Scottish Single Survey

Property address	18 Callander Terrace Dunfermline KY11 8EY
-------------------------	---

Prepared by	Shepherd Chartered Surveyors
--------------------	------------------------------

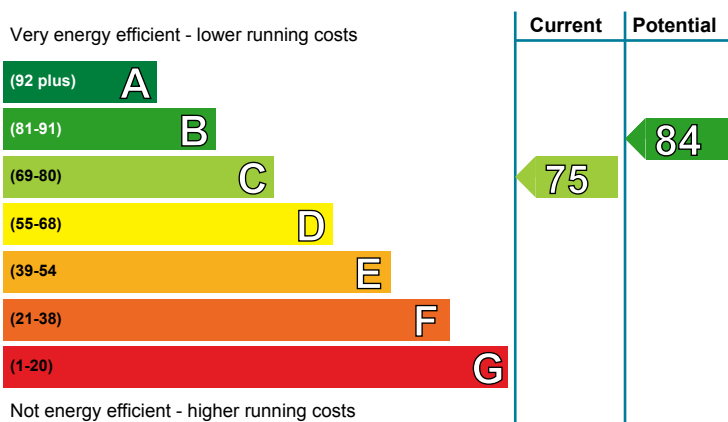
Energy Efficiency Rating

This graph shows the current efficiency of your home, taking into account both energy efficiency and fuel costs. The higher this rating, the lower your fuel bills are likely to be.

Your current rating is **band C (75)**. The average rating for EPCs in Scotland is **band D (61)**.

The potential rating shows the effect of undertaking all of the improvement measures listed within your recommendations report.
