## SINGLE SURVEY REPORT

3 (2F2) BALCARRES STREET  
EDINBURGH  
EH10 5JB

14<sup>th</sup> APRIL 2025

Lyndsay Gowans, MA (Hons) MRICS

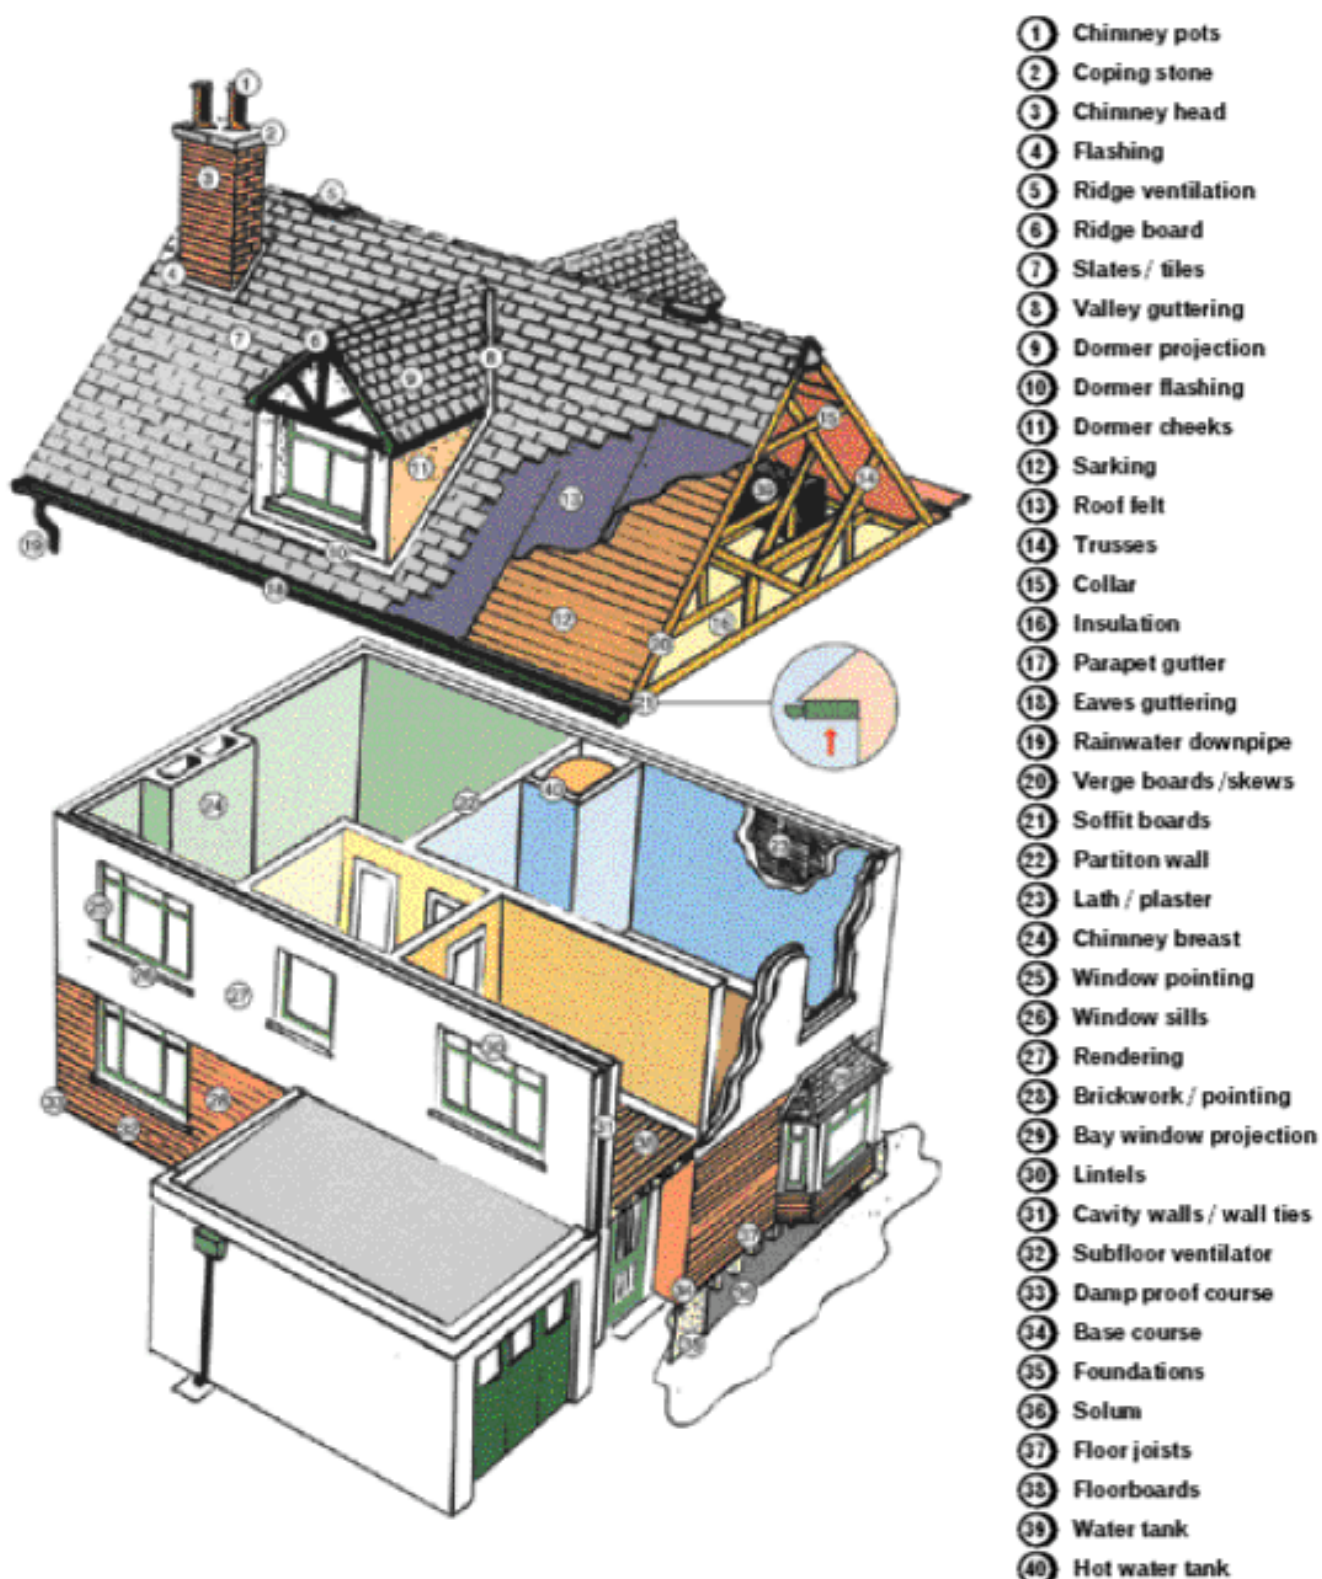
Sectional diagram showing elements of a typical house

Reference may be made in this report to some or all of the above component parts of the property. This diagram may assist you in locating and understanding these terms.

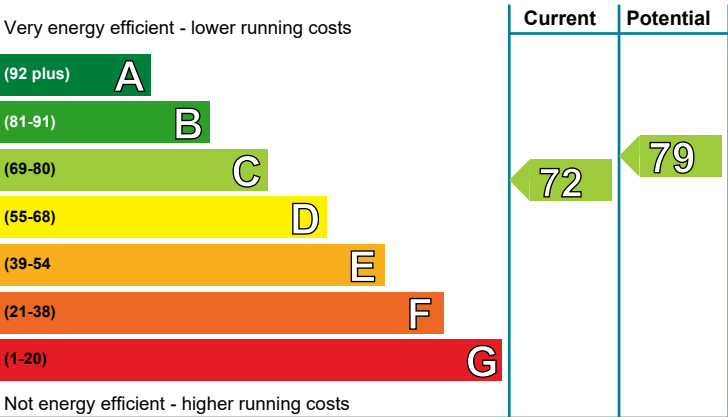
### Energy Efficiency Rating

This graph shows the current efficiency of your home, taking into account both energy efficiency and fuel costs. The higher this rating, the lower your fuel bills are likely to be.

Your current rating is **band C (72)**. The average rating for EPCs in Scotland is **band D (61)**.

The potential rating shows the effect of undertaking all of the improvement measures listed within your recommendations report.

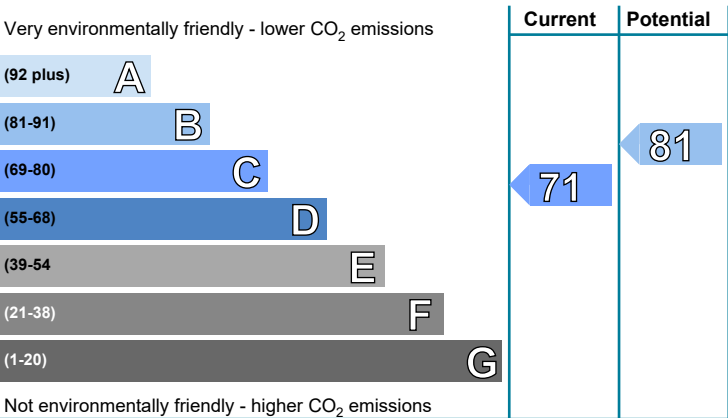
### Environmental Impact (CO<sub>2</sub>) Rating

This graph shows the effect of your home on the environment in terms of carbon dioxide (CO<sub>2</sub>) emissions. The higher the rating, the less impact it has on the environment.
