HOME REPORT

35 SOUTH MARSHALL STREET GRANGEMOUTH FK3 8LR

SINGLE SURVEY

survey report on:

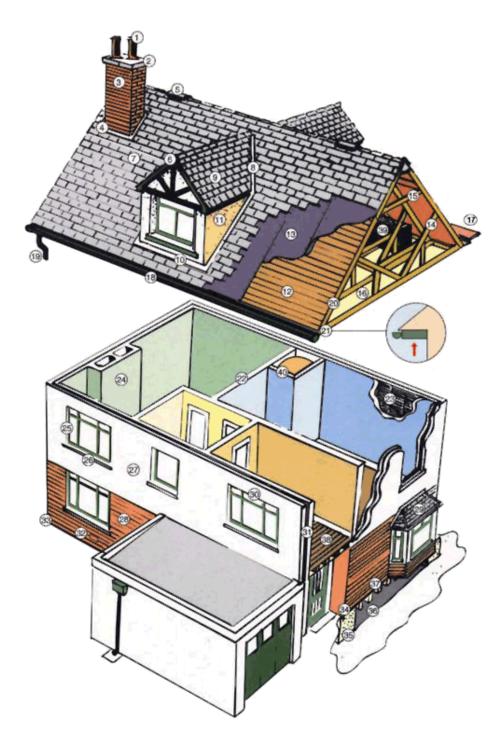
Sectional Diagram showing elements of a typical house

Reference may be made in this report to some or all of the above component parts of the property. This diagram may assist you in locating and understanding these items.

- 1) Chimney pots
- 2) Coping stone
- 3) Chimney head
- 4 Flashing
- 5 Ridge ventilation
- 6 Ridge board
- 7) Slates / tiles
- 8 Valley guttering
- 9 Dormer projection
- 10) Dormer flashing
- 11) Dormer cheeks
- (12) Sarking
- (13) Roof felt
- (14) Trusses
- 15) Collar
- (16) Insulation
- (17) Parapet gutter
- (18) Eaves guttering
- (19) Rainwater downpipe
- 20) Verge boards/skews
- 21) Soffit boards
- 22) Partition wall
- 23) Lath / plaster
- (24) Chimney breast
- 25) Window pointing
- 6) Window sills
- 27) Rendering
- (28) Brickwork / pointing
- 29) Bay window projection
- (30) Lintels
- (31) Cavity walls / wall ties
- 32) Subfloor ventilator
- 33) Damp proof course
- 34) Base course
- 35) Foundations
- 36) Solum
- 37) Floor joists
- 38) Floorboards
- (39) Water tank
- 40 Hot water tank
