# Home Report

20 East Main Street  
Darvel KA17 0DN

# single survey

<b>Property address</b>	20 East Main Street Darvel KA17 0DN
<b>Customer</b>	Tia Campbell
<b>Prepared by</b>	Graham + Sibbald LLP

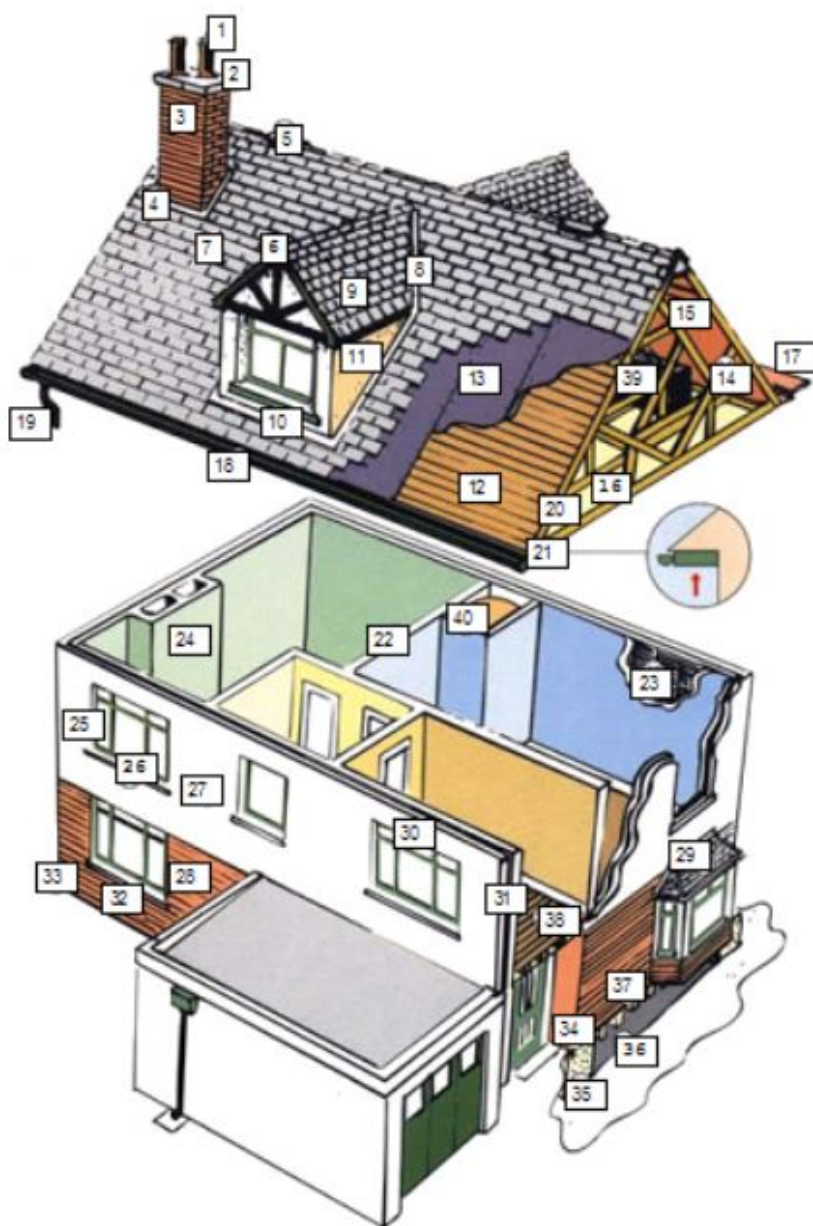
## Sectional Diagram showing elements of a typical house

1	Chimney pots
2	Coping stone
3	Chimney head
4	Flashing
5	Ridge ventilation
6	Ridge board
7	Slates/tiles
8	Valley guttering
9	Dormer projection
10	Dormer flashing
11	Dormer cheeks
12	Sarking
13	Roof felt
14	Trusses
15	Collar
16	Insulation
17	Parapet gutter
18	Eaves guttering
19	Rainwater downpipe
20	Verge boards / skewes
21	Soffit boards
22	Partition wall
23	Lath / plaster
24	Chimney breast
25	Window pointing
26	Window sills
27	Rendering
28	Brickwork / pointing
29	Bay window projection
30	Lintels
31	Cavity walls / wall ties
32	Subfloor ventilator
33	Damp proof course
34	Base course
35	Foundations
36	Solum
37	Floor joists
38	Floorboards
39	Water tank
40	Hot water tank

Reference may be made in this report to some or all of the above component parts of the property. This diagram may assist you in locating and understanding these items.

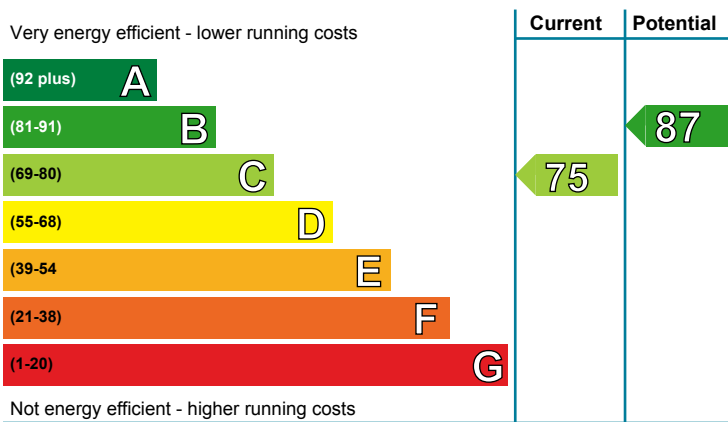
## Energy Efficiency Rating

This graph shows the current efficiency of your home, taking into account both energy efficiency and fuel costs. The higher this rating, the lower your fuel bills are likely to be.

Your current rating is **band C (75)**. The average rating for EPCs in Scotland is **band D (61)**.

The potential rating shows the effect of undertaking all of the improvement measures listed within your recommendations report.

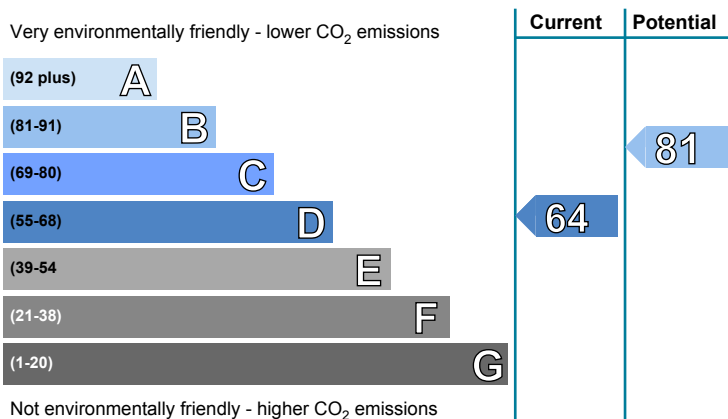
## Environmental Impact (CO<sub>2</sub>) Rating

This graph shows the effect of your home on the environment in terms of carbon dioxide (CO<sub>2</sub>) emissions. The higher the rating, the less impact it has on the environment.
