Property address	Ardpeater
	Caledonian Crescent Gleneagles Auchterarcler
	Auchterärder PH3 ING
	PTIS TIVE

Owner (s) of Property (name)	AMG Group Ltd
------------------------------	---------------

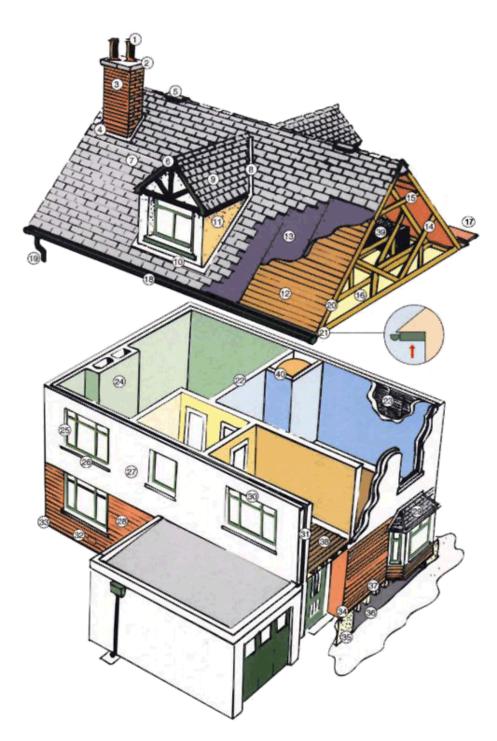
Sectional Diagram showing elements of a typical house

Reference may be made in this report to some or all of the above component parts of the property. This diagram may assist you in locating and understanding these items.

- 1) Chimney pots
- 2) Coping stone
- 3) Chimney head
- 4 Flashing
- 5) Ridge ventilation
- 6) Ridge board
- 7) Slates / tiles
- 8 Valley guttering
- 9 Dormer projection
- 10 Dormer flashing
- 11) Dormer cheeks
- 12) Sarking
- 13) Roof felt
- (14) Trusses
- (15) Collar
- 16 Insulation
- 17) Parapet gutter
- (18) Eaves guttering
- 19 Rainwater downpipe
- 20) Verge boards/skews
- 21) Soffit boards
- 22) Partition wall
- 23) Lath / plaster
- 24) Chimney breast
- (25) Window pointing
 - 6) Window sills
- 27) Rendering
- (28) Brickwork / pointing
- 29) Bay window projection
- 30) Lintels
- (31) Cavity walls / wall ties
- 32) Subfloor ventilator
- (33) Damp proof course
- 34) Base course
- 35) Foundations
- 36) Solum
- 37) Floor joists
- 38) Floorboards
- 39) Water tank
- 40) Hot water tank
