# HOME REPORT

FLAT GR  
11 SOUTH DEAN ROAD  
NEW FARM LOCH  
KILMARNOCK  
KA3 7RB

# Energy Performance Certificate (EPC)

# Single Survey

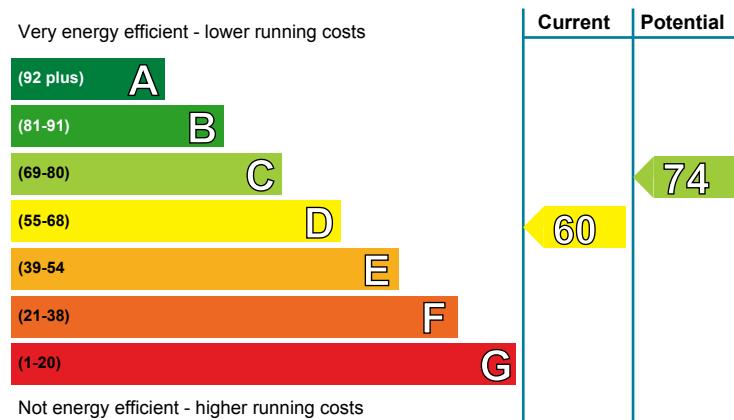
## Energy Efficiency Rating

This graph shows the current efficiency of your home, taking into account both energy efficiency and fuel costs. The higher this rating, the lower your fuel bills are likely to be.

Your current rating is **band D (60)**. The average rating for EPCs in Scotland is **band D (61)**.

The potential rating shows the effect of undertaking all of the improvement measures listed within your recommendations report.

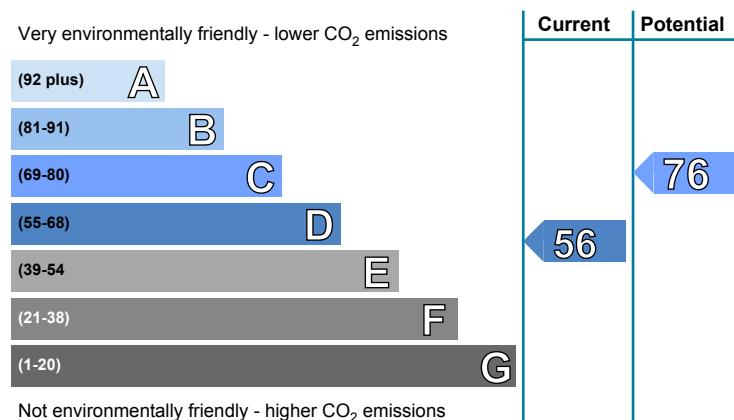
## Environmental Impact (CO<sub>2</sub>) Rating

This graph shows the effect of your home on the environment in terms of carbon dioxide (CO<sub>2</sub>) emissions. The higher the rating, the less impact it has on the environment.

Your current rating is **band D (56)**. The average rating for EPCs in Scotland is **band D (59)**.

The potential rating shows the effect of undertaking all of the improvement measures listed within your recommendations report.
