HOME REPORT

BYREHOLM DALGARVEN

KILWINNING
KA13 6PL

Energy Performance Certificate (EPC)

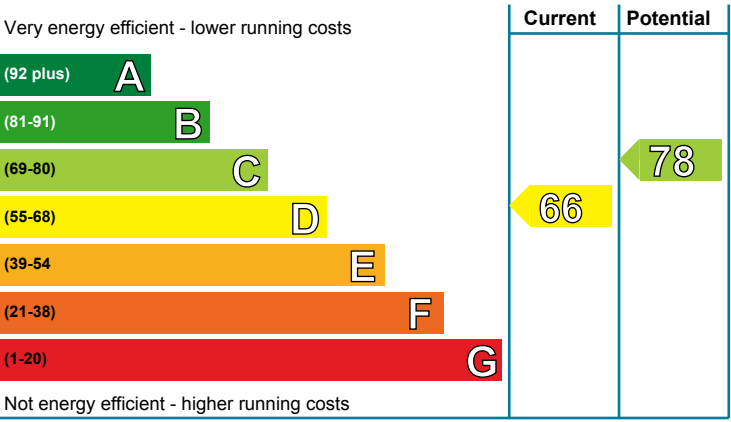
Energy Efficiency Rating

This graph shows the current efficiency of your home, taking into account both energy efficiency and fuel costs. The higher this rating, the lower your fuel bills are likely to be.

Your current rating is **band D (66)**. The average rating for EPCs in Scotland is **band D (61)**.

The potential rating shows the effect of undertaking all of the improvement measures listed within your recommendations report.

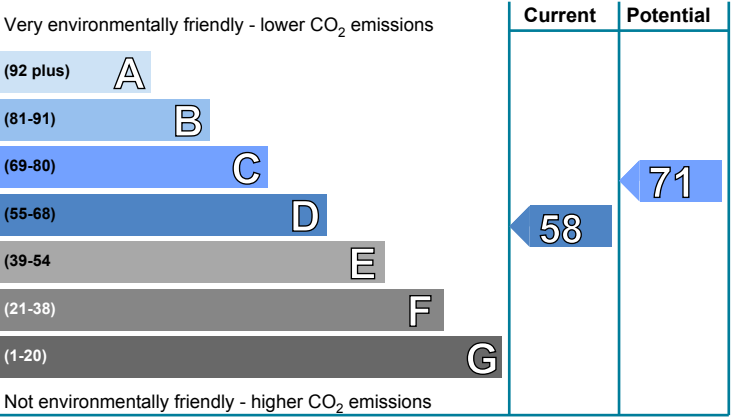
Environmental Impact (CO₂) Rating

This graph shows the effect of your home on the environment in terms of carbon dioxide (CO₂) emissions. The higher the rating, the less impact it has on the environment.

Your current rating is **band D (58)**. The average rating for EPCs in Scotland is **band D (59)**.

The potential rating shows the effect of undertaking all of the improvement measures listed within your recommendations report.
